NUCLEAR INCIDENT AT THE IDAHO CHEMICAL PROCESSING PLANT

NUCLEAR INCIDENT
at the
IDAHO CHEMICAL PROCESSING PLANT
on
OCTOBER 16, 1959

REPORT OF THE INVESTIGATING COMMITTEE

PHILLIPS PETROLEUM COMPANY - ATOMIC ENERGY DIVISION
U. S. ATOMIC ENERGY COMMISSION - IDAHO OPERATIONS OFFICE
Idaho Falls, Idaho February 15, 1960

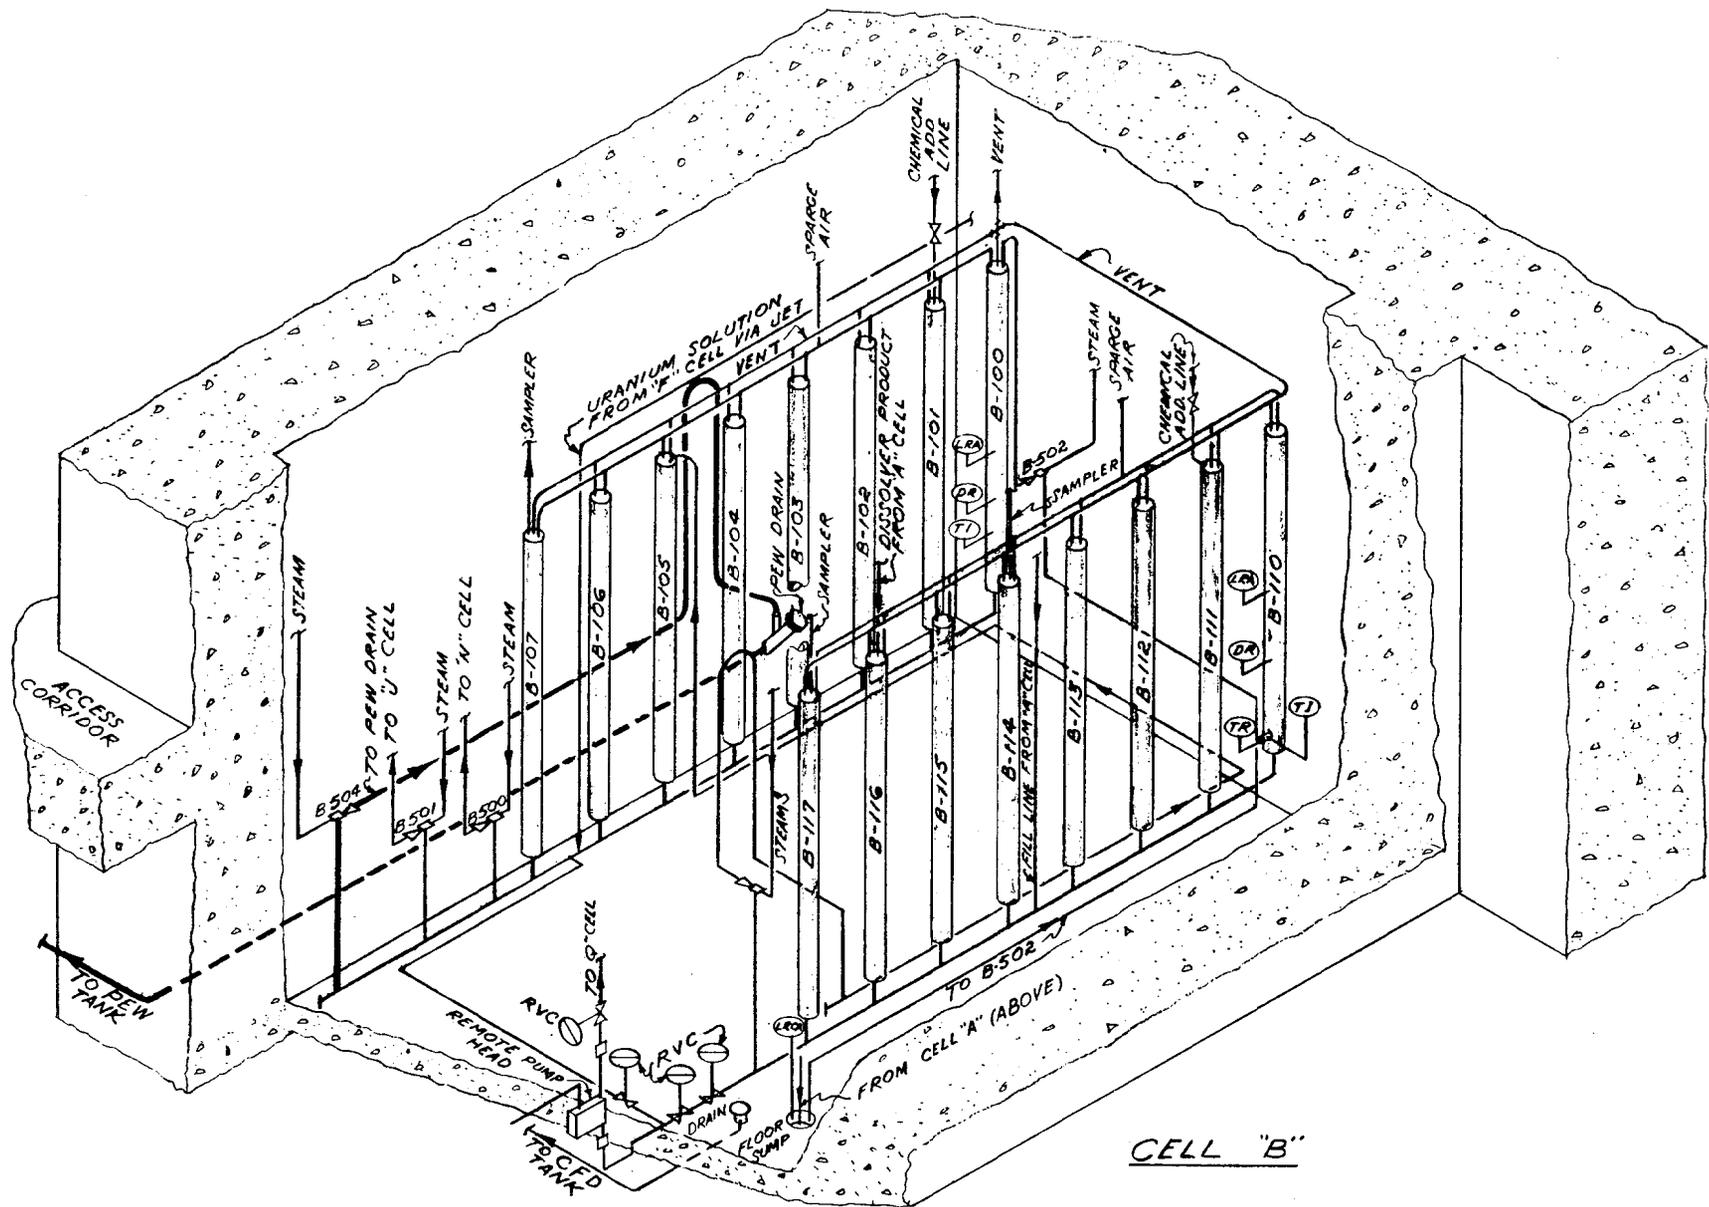
Fig. 2
CELL "B"

The B cell storage vessels consist of two banks of eight 10-foot high by 5-inch schedule 40 pipes connected as illustrated in the simplified sketch of Figure 2. During the first few transfers of intermediate product from F cell to B cell, a cautious approach to flowsheet concentrations resulted in some rather low density (low uranium concentration) solution being admitted to B cell storage vessels. The nature of this equipment is such that this less dense material filled the transfer lines and thus constituted the bulk of the material in the hydrostatic seal of the bank at the time of sparging.

Since both of the banks were to be used to store product from the stainless steel fuels, the bottom connection between banks was left open to allow both to fill simultaneously. The actual operating procedure was to close the interconnecting valves, make a transfer, confirm the volume transferred by measuring the volume received in the B-100 bank, then open the valves and allow the banks to equalize again.

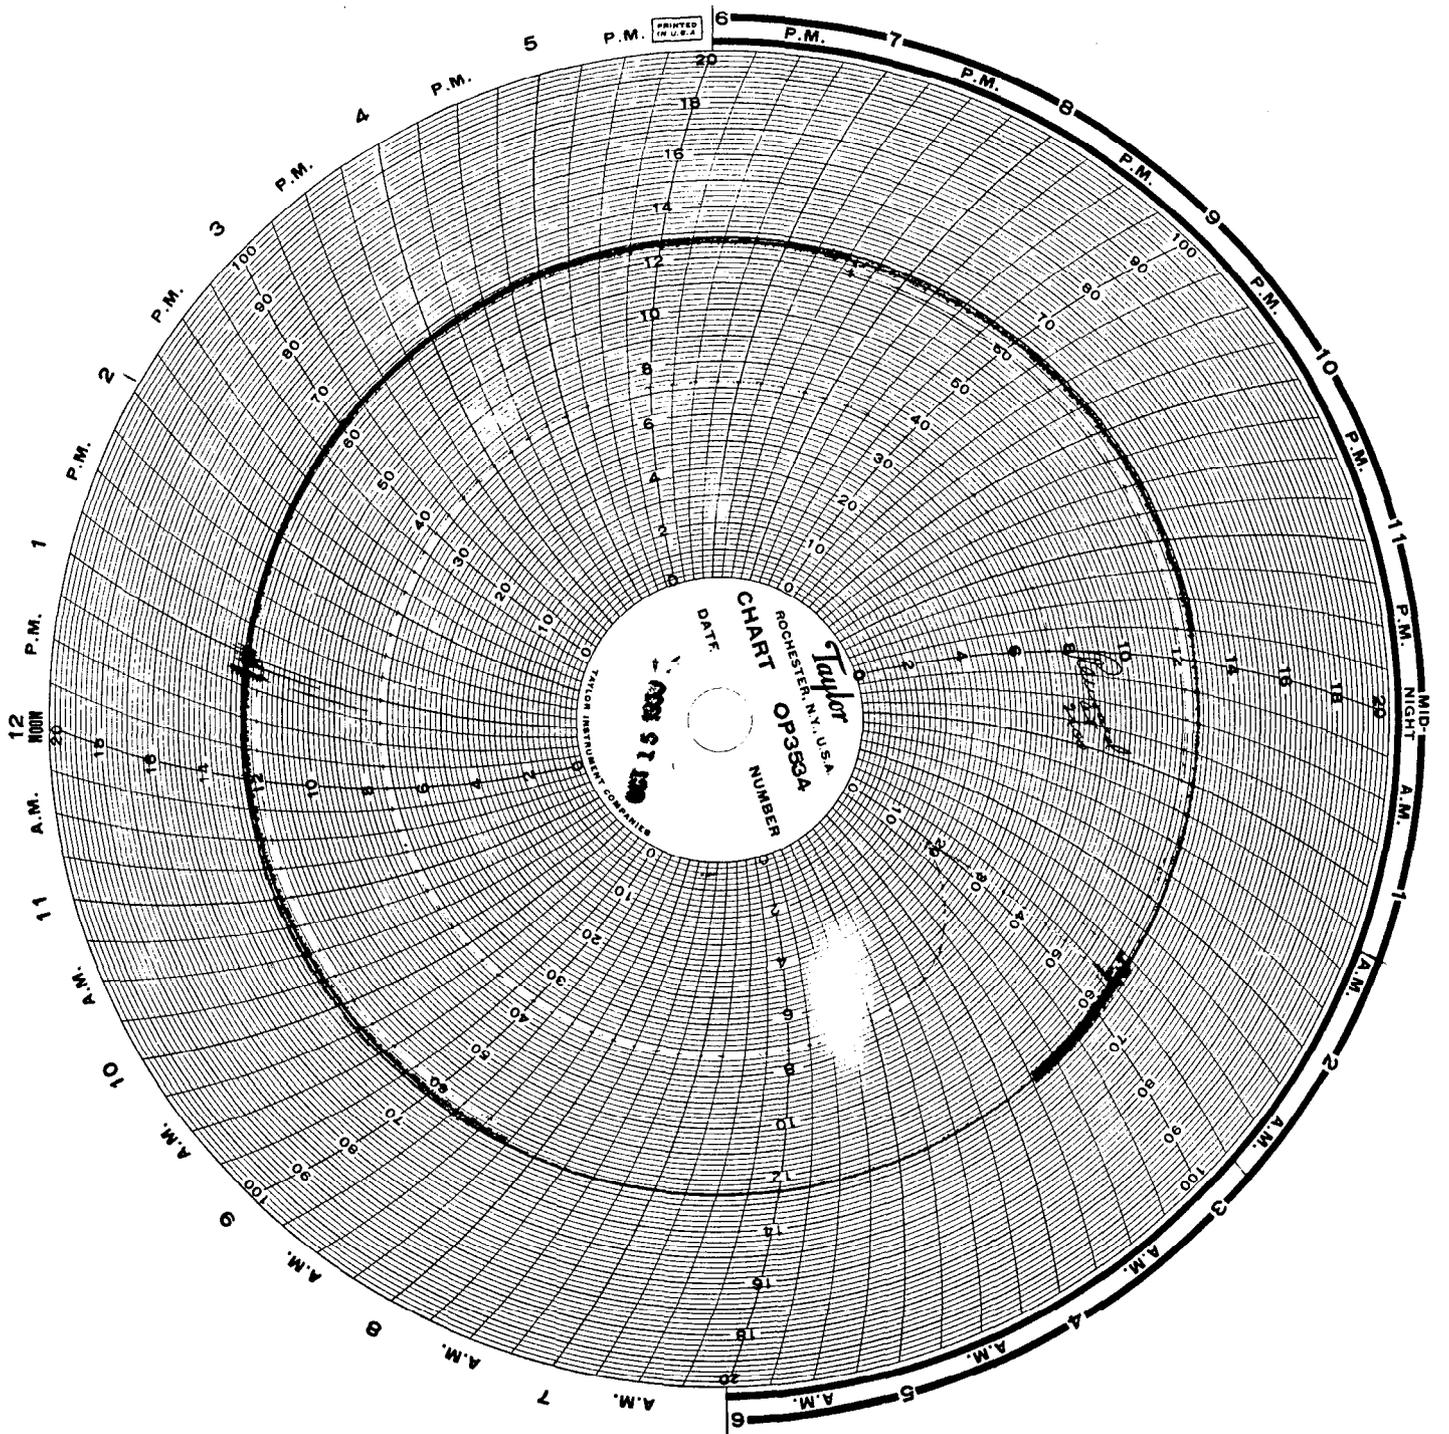
B 100 INSTRUMENT CHART
 0800 October 15 to 2400 October 16
 Liquid Level - Blue, Specific Gravity - Red
 Figure 10

The instrument chart records of liquid level and density (see Figures 10 and 11) indicate that shortly after the start of sparging the liquid level in the B-100 bank dropped uniformly for about the next fifteen minutes, reflecting the loss of liquid from the bank through the waste line to the 5,000-gallon waste storage tank WH-100. Based upon experiments in this equipment, it appears that excessive sparge air introduced to the system and the existence of nonuniform solution density in the banks forced the solution over the protecting hydrostatic pressure barrier formed by extension of the transfer line four feet above the highest liquid level in the banks and started the siphon. From the evidence it is apparent that the steam jet, the normal transfer means through this line, was not operated at any time during the hours preceding the incident.

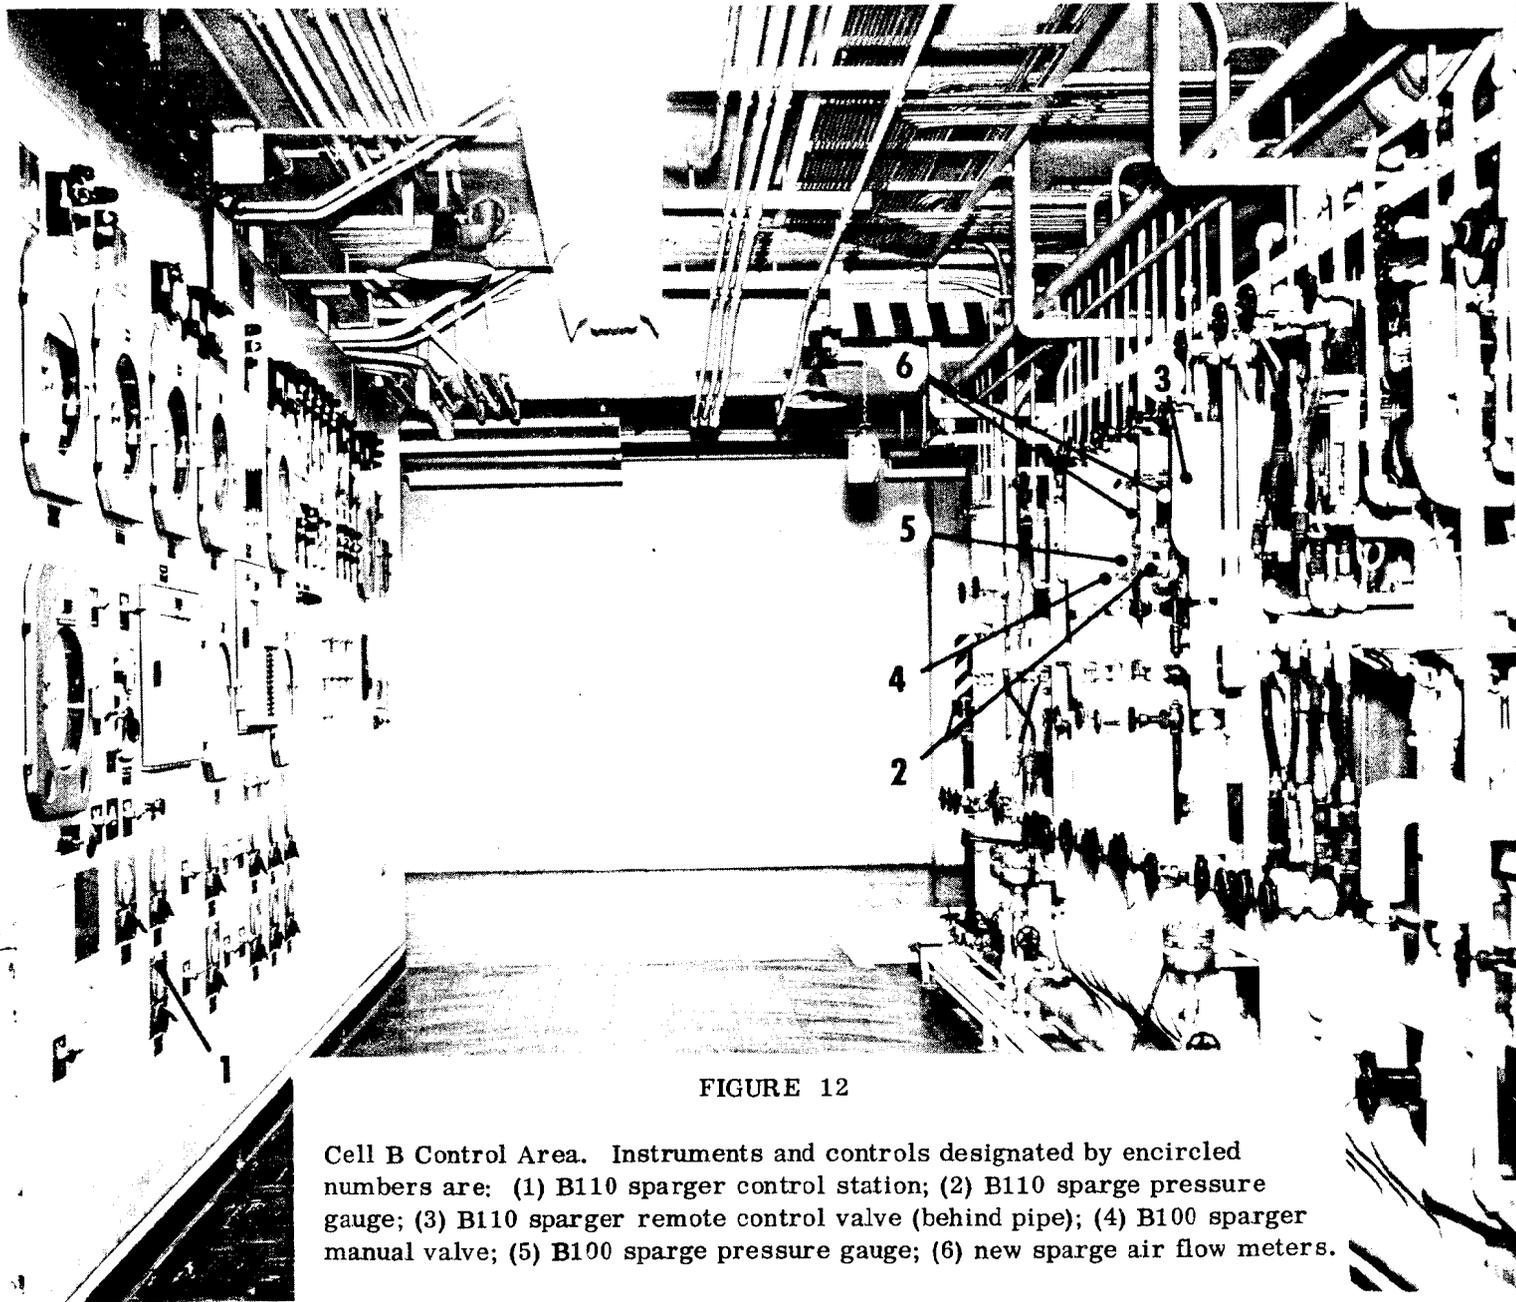
FIGURE 12

As noted earlier the pressure gauge on the B-110 sparger control panel had been disconnected and a new gauge installed on the piping next to the cell wall. None of the operators questioned were aware of this change. As a result, those who operated this sparger had no indication of the sparging rate actually used. In fact, the initial sparging was probably quite violent before it became apparent that the gauge they were observing was inoperable. Also erratic control valve action undoubtedly contributed to the pressure surge. The traces on the B-110 instrument chart (Figure 11) indicate that the sparging on October 15 day shift was probably as violent as the subsequent sparging which initiated the transfer. On both occasions specific gravity and liquid level pens dropped below chart zero momentarily as sparge air was applied. However, since only one person operated both B-100 and B-110 spargers on October 15, it would not have been possible for both pressure surges to have occurred simultaneously. It is now apparent that siphoning through the transfer line seal loop would have been effectively prevented by the existence of a valve in the line, a vent at the high point of the loop, or an enlargement of pipe diameter beyond the high point of the loop.

Cell B Control Area. Instruments and controls designated by encircled numbers are: (1) B110 sparger control station; (2) B110 sparge pressure gauge; (3) B110 sparger remote control valve (behind pipe); (4) B100 sparger manual valve; (5) B100 sparge pressure gauge; (6) new sparge air flow meters.

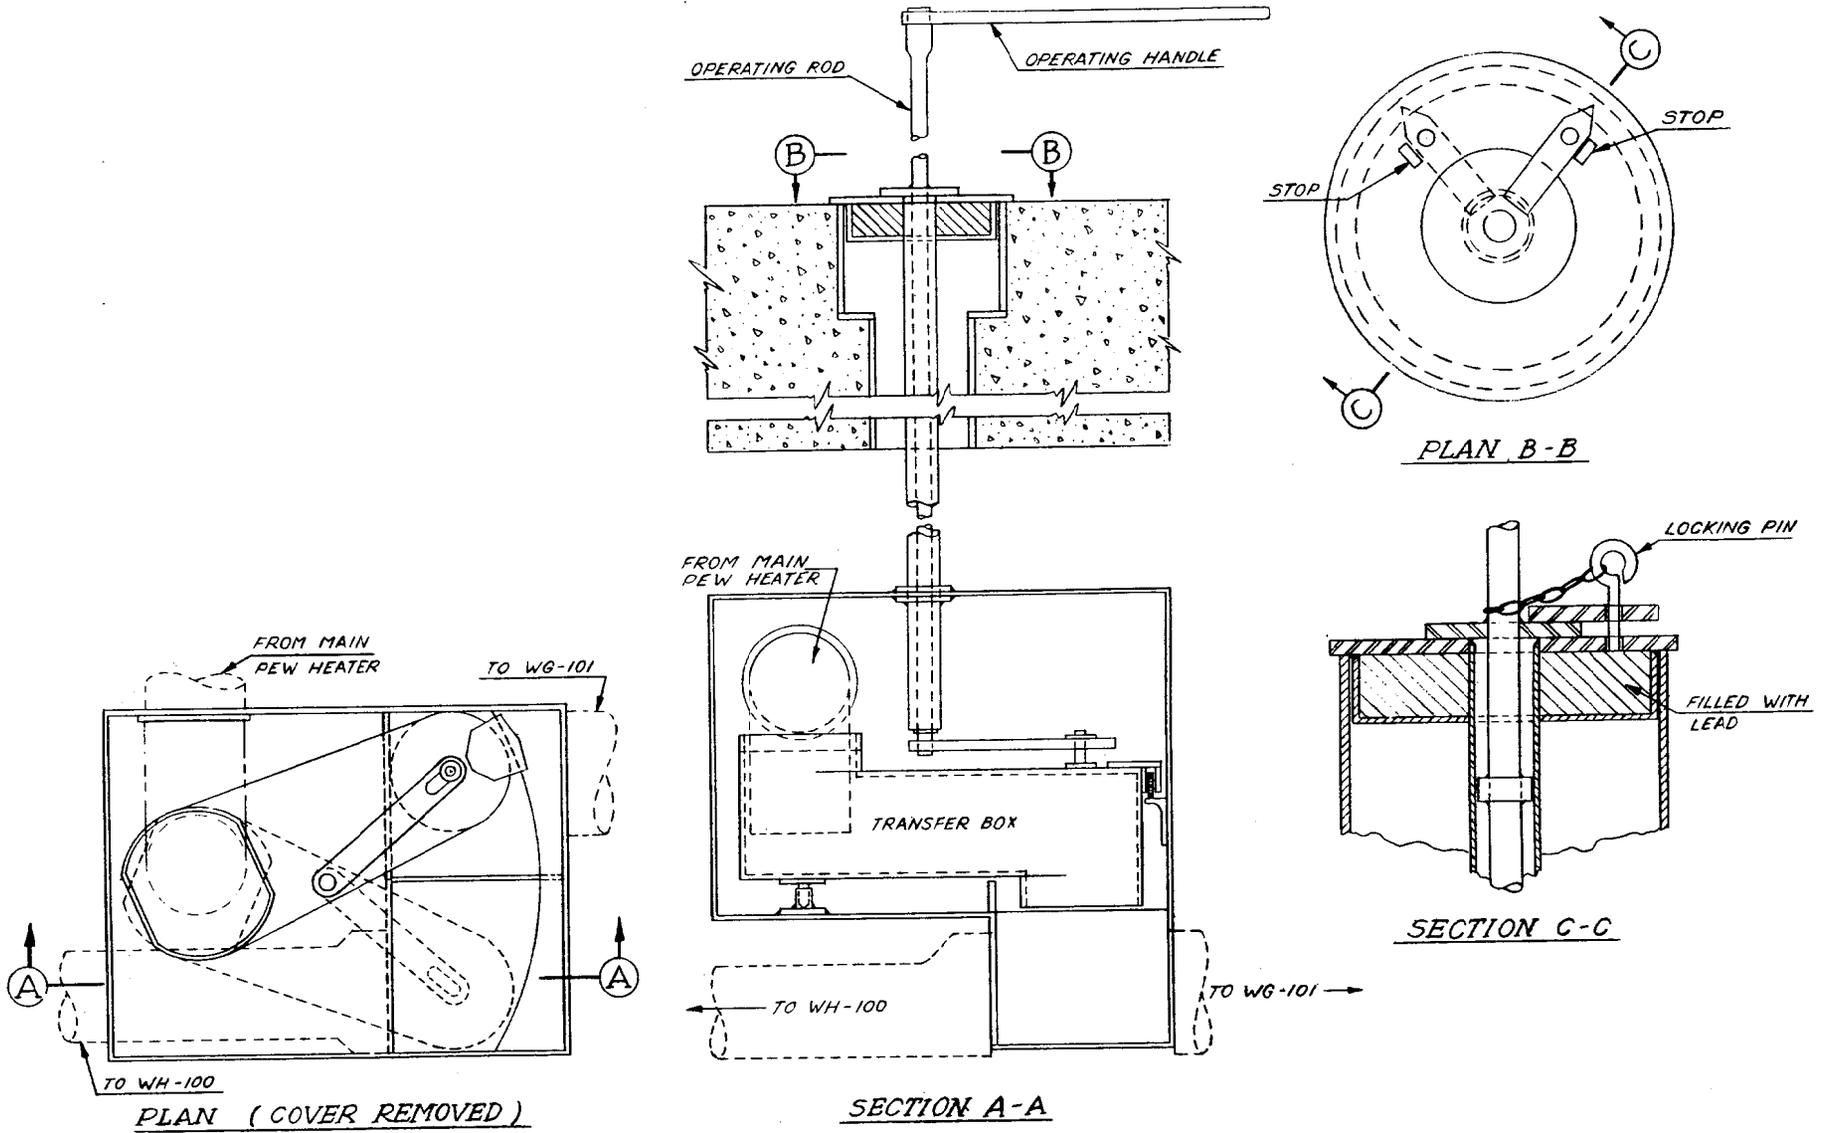
Fig. 13
PEW DIVERSION BOX

The B cell and waste collection tank charts were recovered for careful examination. Although the PEW diversion spout (Figure 13) was found directed to WG-101 immediately after the incident, the 1600-2400 shift on October 15 had reported that they had switched to WH-100 and the instrument chart (Figure 9) verifies that WH-100 had been filling. At the time of the incident WH-100 volume decreased from about 10 per cent (795 liters) to 3 per cent (76 liters), and WG-101 volume increased from

From these tests and other information, it was concluded that the rapid ejection of fluid (either gas, vapor or liquid) from the WH-100 impinged upon the diversion spout with sufficient force to lift the control rod and disengage the locking pin. Resultant forces were in such a direction as to cause the spout to swing to the opposite position toward WG-101. When the forces subsided, the operating rod dropped back into the opposite position and allowed the locking pin to engage the hole in the locking plate. When observed later by the reconnaissance crew, the mechanism was in the exact position that would be expected had it been deliberately set for flow to WG-101.

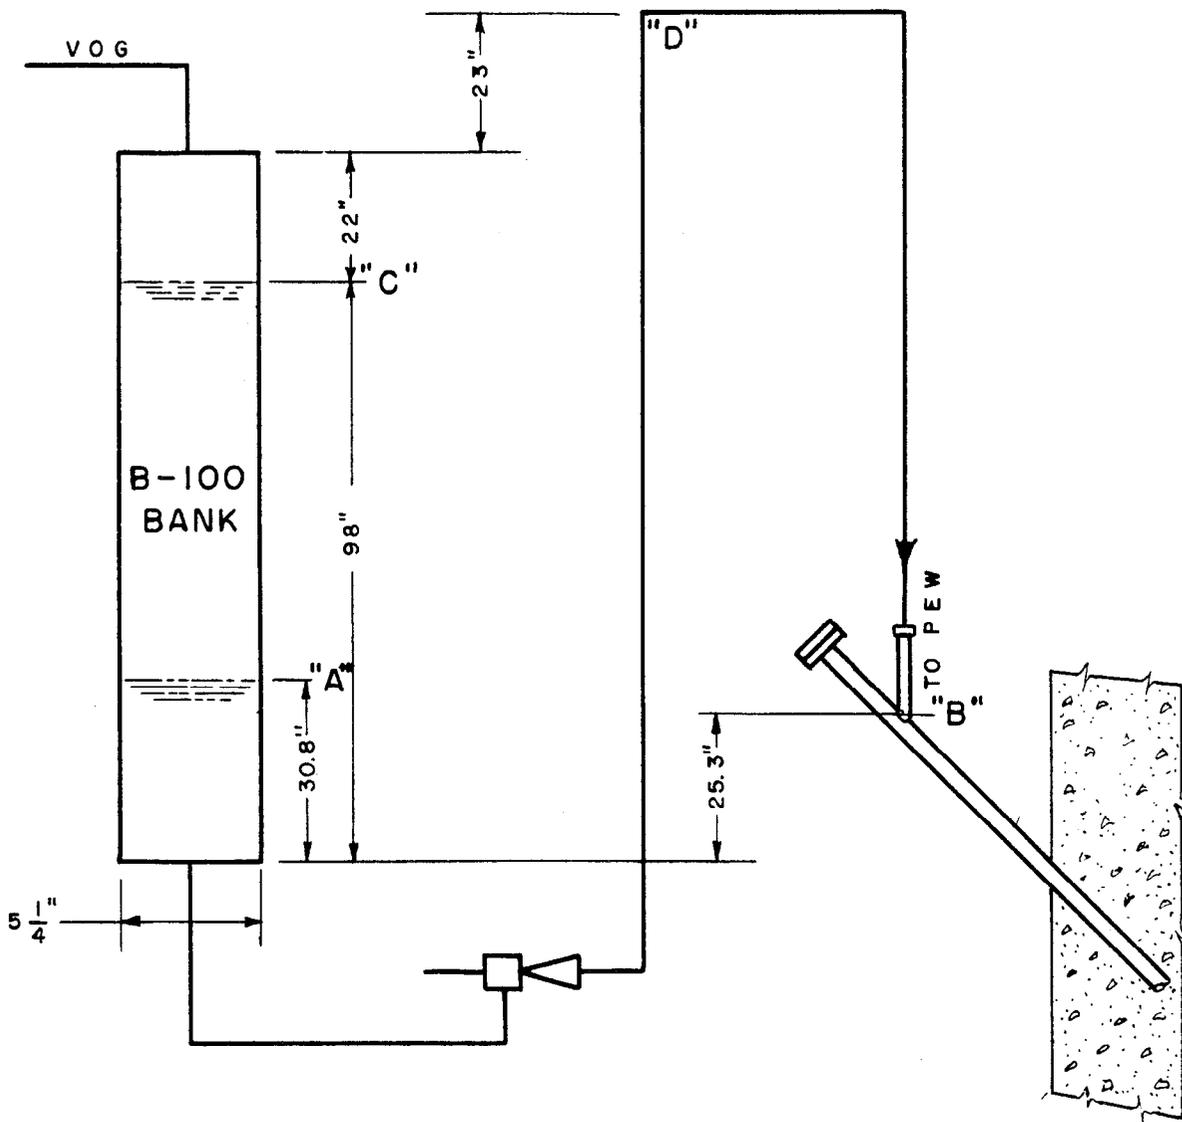
Fig. 23
SCHEMATIC DIAGRAM OF B-100 BANK
& PEW JET TRANSFER LINE

The siphoning which occurred during the testing period stopped after 11 to 14.3 minutes, and the final levels reached ranged from 22 to 7.5 per cent as compared to approximately 15 minutes and 18 per cent at the time of the incident. It was found that the siphon generally stopped with the liquid level in the vessel slightly above the level of the PEW line connection; however, this was somewhat dependent on the pressure in the vessel. During the tests a section of flexible Tygon tubing was substituted for a section of the stainless steel tubing in the PEW transfer line (just before entrance to the 2-inch line) for direct observation of liquid flow. Figure 23 gives the elevations of critical points in the system. During the siphonings the flexible tubing was partially collapsed. This increased the velocity of the liquid through the tubing and probably prolonged the siphoning. The resultant increase in velocity through the Tygon tubing section, as well as the effects of sparging and variations in vessel pressure, probably contributed to the variations in final levels reached when siphonings stopped. It is therefore concluded that the siphon at the time of the incident could have stopped of its own accord without any assistance from a shock wave as a result of the incident.

- "A" - Depth at which siphoning stopped.
- "B" - Height of transfer line enlargement above bottom of B-100 BANK.
- "C" - Depth of UNH solution prior to incident.
- "D" - Height of top of Hydrostatic Seal above B-100 BANK.

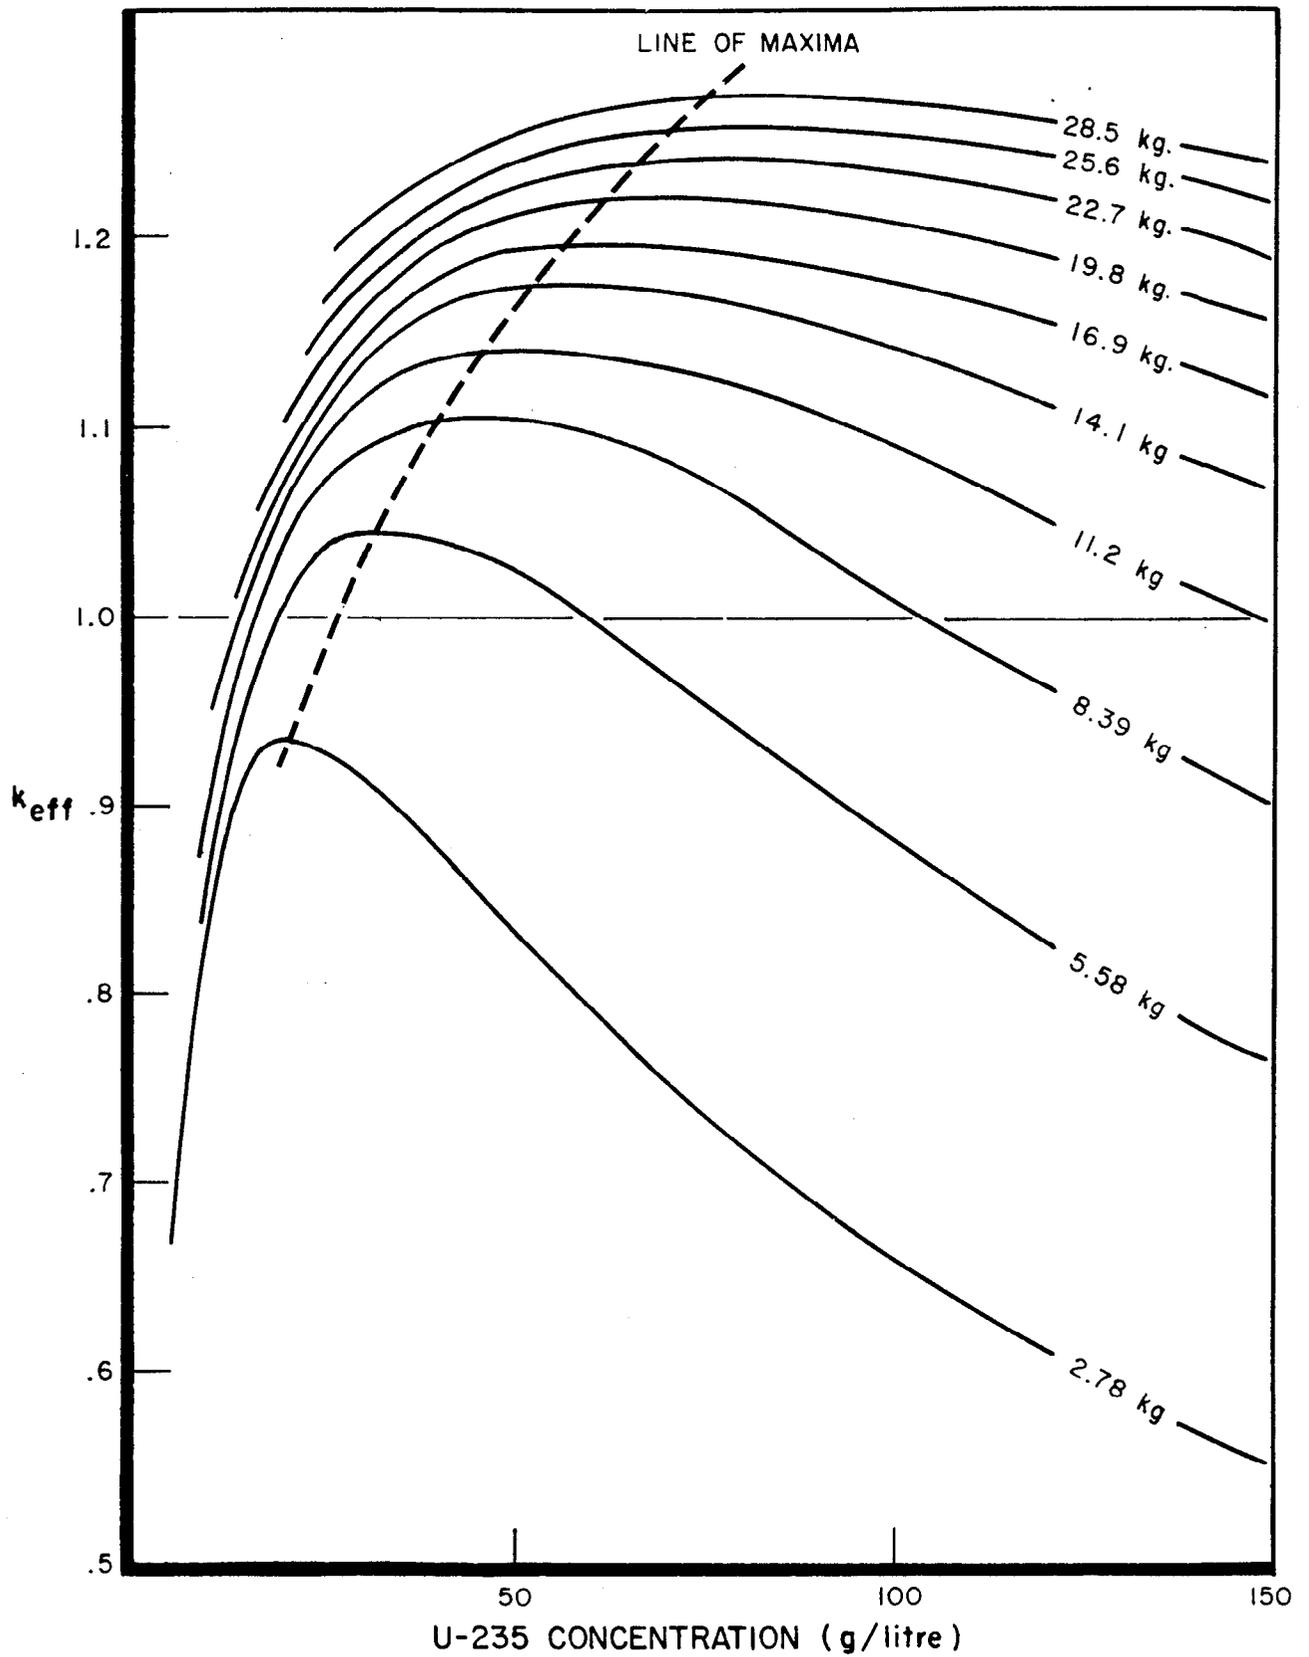
Fig. 24
 PLOT OF k_{eff} AT SUCCESSIVE STATIONARY STATES

It was calculated that for each chosen state there existed a concentration for which k_{eff} is a maximum. (See Figure 24.) The far right of each curve corresponds to no mixing and the far left to complete mixing. The highest ramp rate--that for optimum dilution--is found to be of the order of $2 \times 10^{-3} \text{ sec}^{-1}$ as estimated from the cross-plots of Figure 25. Based upon SPERT experience and data available from KEWB, it is estimated that a peak power of 10^8 watts was attained. It is not likely that a single burst would account for the total number of fissions (approximately 4×10^{19}); it is more likely that the reaction continued for at least ten seconds and probably as long as several minutes. It is not likely that the system could have gone critical in less than two minutes after product solution began to flow into WH-100 when it would have contained about 4 kg U-235.
