U.S. Department of Energy

Trip Report

Visit to Tokyo and Tokai-Mura, Japan

**Information Exchange with
Government of Japan Concerning
The September 30, 1999
Tokai-Mura
Criticality Accident**

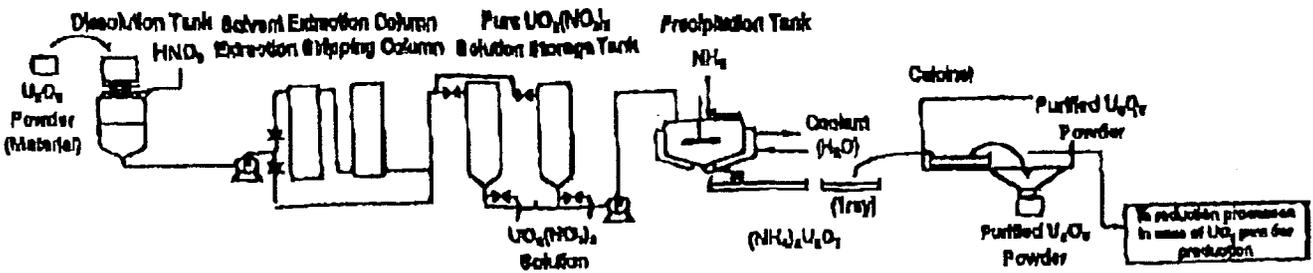
Figure 2. The JCO conversion process as it was permitted under the license granted in 1984. This license permitted the dissolution of 2.4 kg U_3O_8 when the enrichment was between 16 and 20 %. It allowed the option of taking off $UO_2(NO_3)_2$, U_2O_7 , and UO_2 as products. It also allowed the feed to be from either the hydrolysis of UF_6 up to 20% enriched, or from the direct dissolution of U_3O_8 up to 20% enriched or of scrap up to 50% enriched.

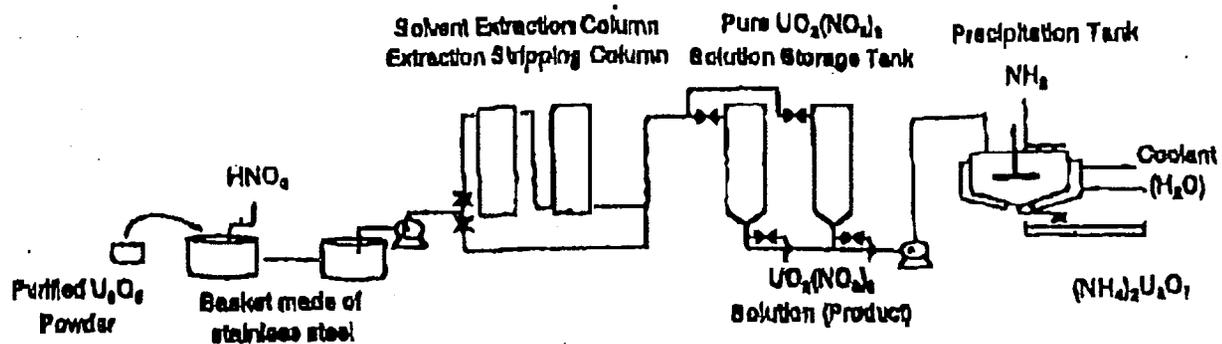
Subsequent to initial operations in the Conversion building for intermediate enriched uranium, in 1986, an unreviewed and unapproved change was made to the flow sheet where the dissolution was carried out in a stainless steel bucket and then pumped into the geometrically favorable storage tanks. This reduced the amount of time needed to complete a processing cycle. A second unreviewed and unapproved change was later made to a company procedure in which the dissolver was formally removed from the process and a bucket for the dissolution put in its place. This procedure still required the dissolved product to be pumped into the geometrically favorable tanks for storage. The procedure and flowsheet, which were provided to the delegation by Japanese officials, indicated that multiple batches (six to seven) containing about 15,000 grams of intermediate enrichment uranium, could have been accumulated in the geometrically favorable storage tanks. This unreviewed provision would have allowed for violation of specified mass limits contrary to the license. These changes are shown Figure 3 of Attachment D.

Figure 3. The modified procedure that allowed the use of a stainless steel basket as a dissolution vessel. The resultant solution was to be pumped into the system for storage in the geometrically favorable solution storage tanks.

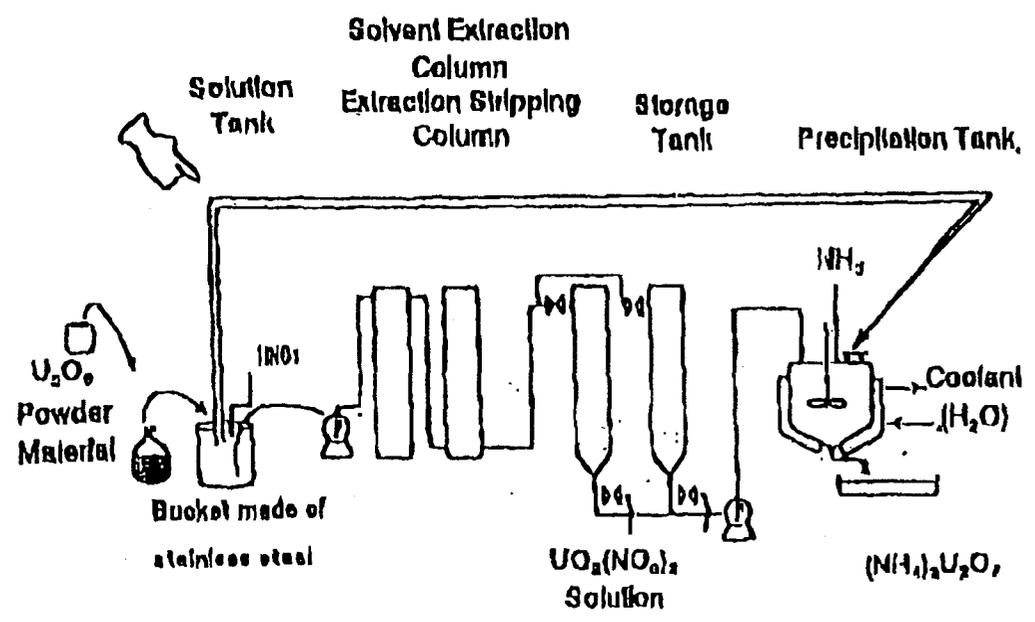
A final unreviewed and unapproved modification to the process was informally made prior to the 1999 conversion of uranium oxide to uranyl nitrate. A decision, apparently made to save time and facilitate ease of handling of the uranyl nitrate solution, provided for continuing dissolution in the stainless steel buckets but, instead of pumping the uranyl nitrate product into the geometrically favorable storage tanks, provided for transferring the solution directly into the precipitation vessel by pouring it through a funnel in the large 10" diameter nozzle in the top of the vessel. This decision also provided for accumulating several batches of uranyl nitrate in the precipitation vessel thereby significantly exceeding specified mass limits established by the license. These activities were conducted contrary to procedures, the license, and established safety controls. This final process modification is shown in Figure 4 of Attachment D.

Based on the information presented, the delegation believes that the cause of this accident was the accumulation of uranyl nitrate, contrary to specified mass limits, directly into a precipitation vessel, contrary to its designed use and contrary to procedure, until a sufficient quantity of intermediate enriched uranium was available to initiate and sustain a nuclear criticality reaction.

Figure 4. The procedure that was used at the time of the criticality accident. Batches containing 2.4 kg U_2O_5 were dissolved in a stainless steel bucket. The batch was then transferred to a 5-liter beaker and then physically transported to the precipitation tank where it was poured through a funnel into the tank. Seven batches of solution were added to the tank before it went critical.
