THE ACCIDENT TO THE NRX REACTOR ON DECEMBER 12, 1952

DR-32

BY
W.B. LEWIS

JULY 13, 1953

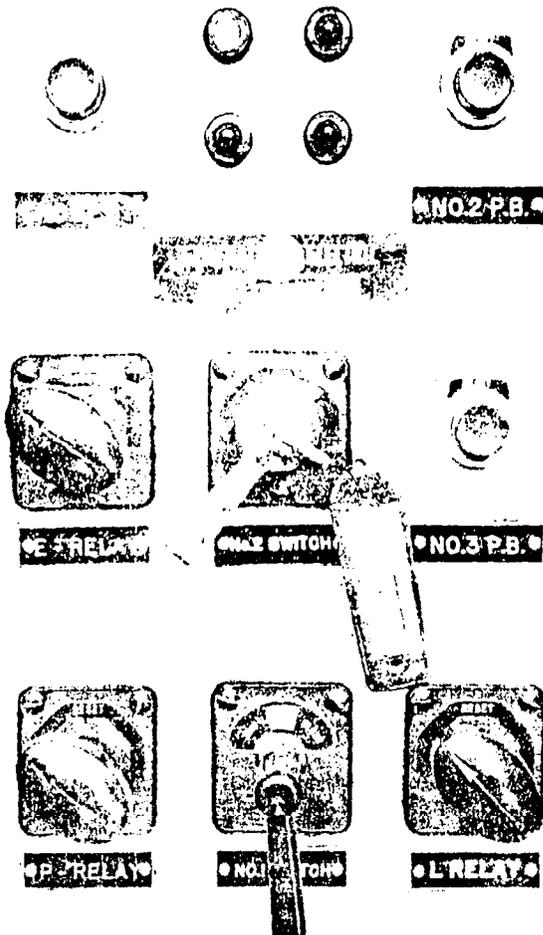
Fig. 1—Central panel on control desk.

Push button 3 serves to increase temporarily the current through all solenoid magnets in the shut-off-rod head system. This ensures good seating of the air-release valves and also draws the pistons on the shut-off rods fully home. The normal maintained current is adequate to hold the rods and valves in position. Excess current above the minimum would delay release.

To ensure satisfactory operation, push button 3 is pressed in conjunction with push buttons 4, 1, and 2. If it is not pressed with push button 4, air may leak from the head system; if it is not pressed with 1 and 2, the shut-off rods may not be drawn fully home, and safety circuits would prevent the start-up operation from proceeding further.
