**Summary of Two Criticality  
Accidents at the Russian  
Research Center  
“Kurchatov Institute”**

**INEEL/EXT-98-00409**  
**August 1998**

**Dr. D. M. Parf<sup>f</sup>anovich**  
**Russian Research Center "Kurchatov Institute"**

**Edited by J. Blair Briggs**  
**Idaho National Engineering and Environmental Laboratory**

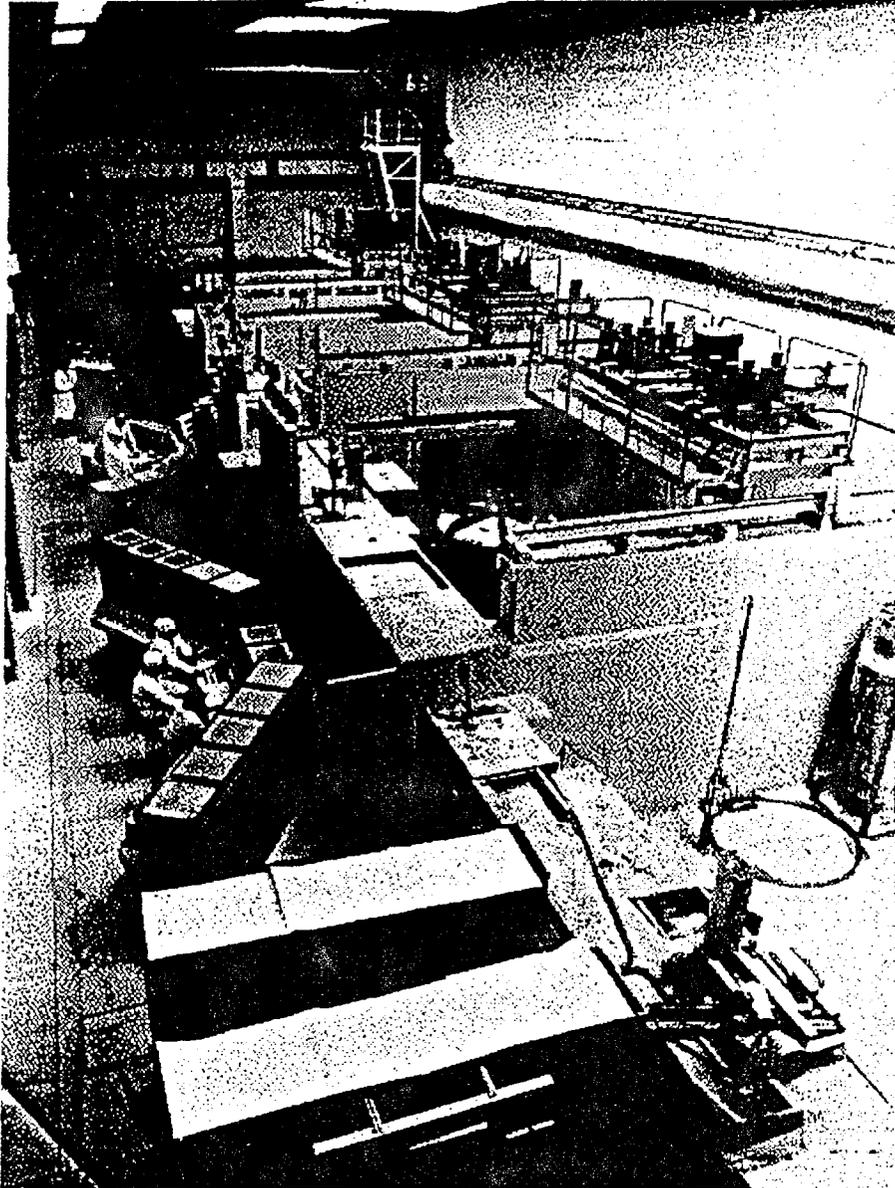
The core configuration with the beryllium reflector was assembled in the dry critical facility tank and left for the night. The next morning D. A. Mastin entered the facility control room (see Figure 1) and without waiting for the arrival of the control desk operator and the controlling physicist, switched on the pump and began adding water to the critical assembly tank. D. A. Mastin considered the system to be far from critical. The control equipment was switched on but the neutron source had not been placed in the critical assembly and the control rods were not actuated.

The two major causes of this accident are as follows:

1. An inaccurate determination was made that the reactivity worth of the beryllium reflector (calculations had not been performed) was essentially the same as the iron reflector (calculations had been performed).

2. Serious violations of SF-7 operating requirements occurred.
  - Action that could change the core reactivity should have been considered an experiment. The addition of water was an obvious change to the core reactivity and should not have been initiated without a full operating crew (scientific leader, controlling physicist and the control desk operator).

Figure 1. Photograph of the SF-7 control and experimental rooms in which the first accident occurred.

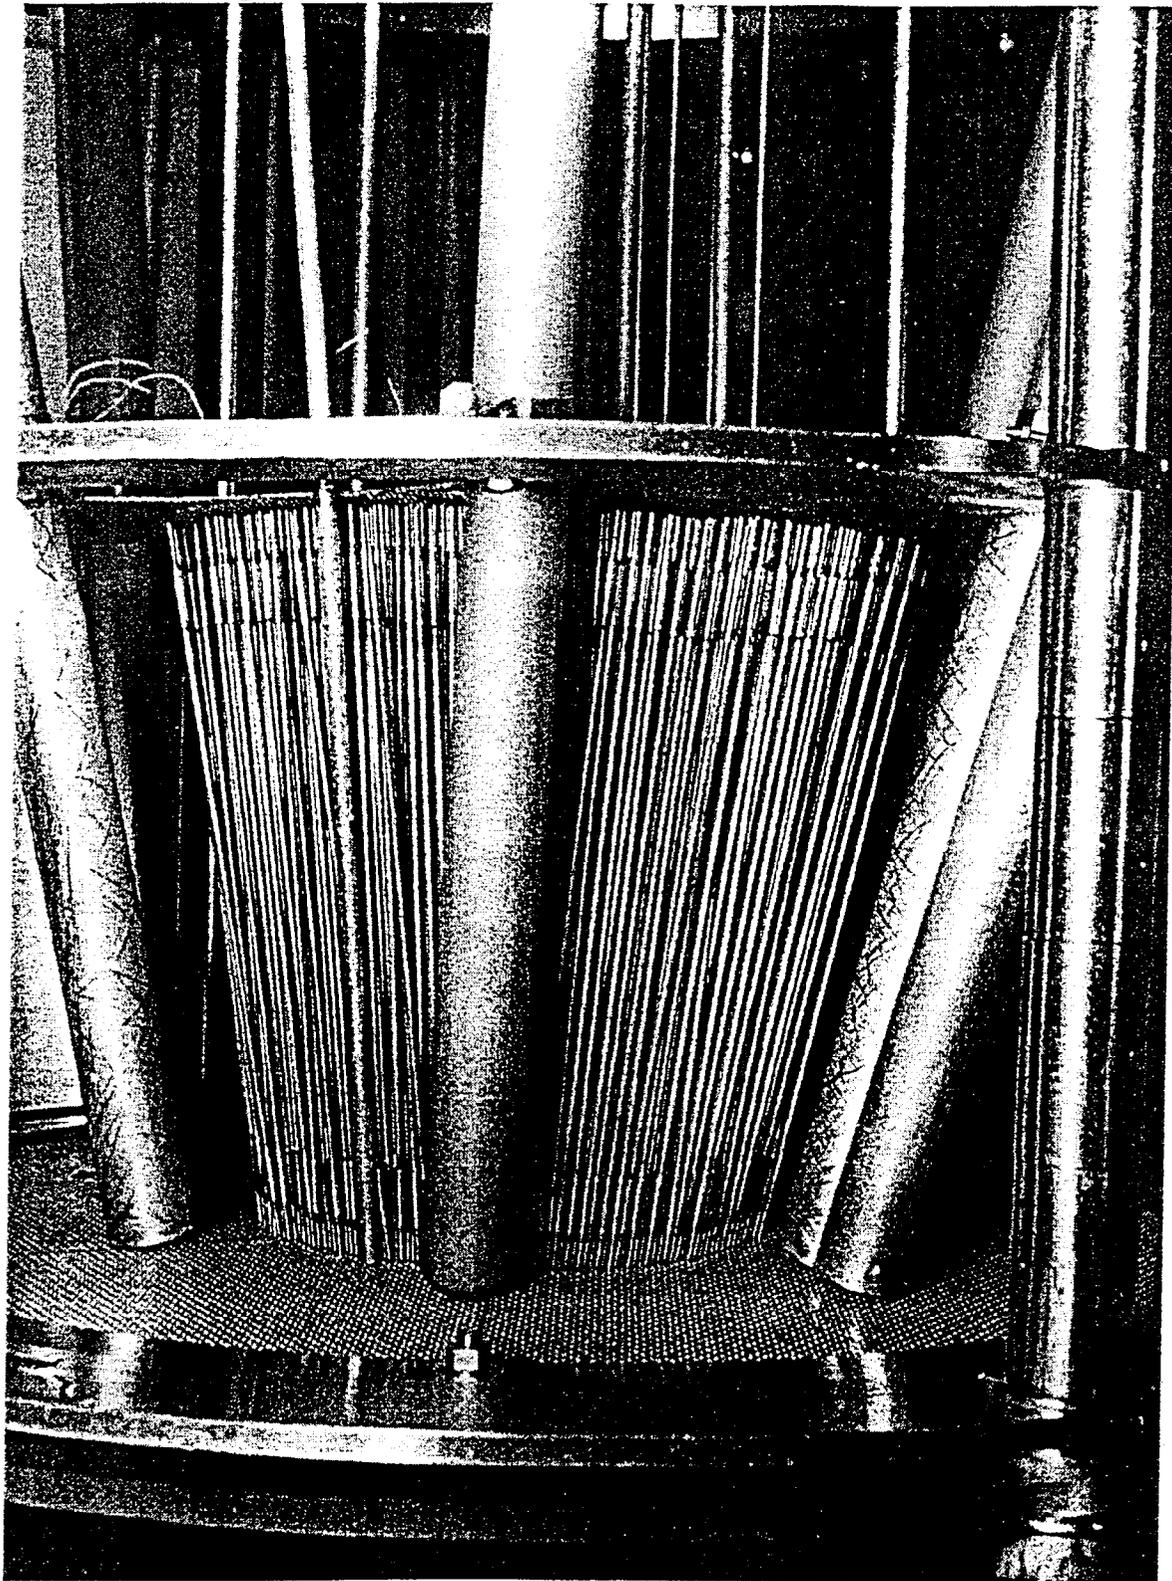
The Plexiglas<sup>®</sup> support plate almost completely covered the tank section and the size of the gap between the plate edge and tank wall was less than the size of the fast dumping valve outlet. For this reason, upon initiating the fast dumping operation, the Plexiglas<sup>®</sup> base plate sagged and the fuel rods fell out of the upper lattice plate (see Figure 2). The fuel rods fell into a fan-shaped array in which the pitch between rods came close to optimum and the lattice went critical. The rate of reactivity insertion was calculated to reach  $\sim 2 \beta_{eff}/\text{second}$ .

During the criticality accident, two periphery rows of fuel rods were destroyed by the energy release. Fragments of these fuel rods resembled welding rod fragments. Water splashed out of the tank.

The construction of the critical assembly was the main cause of the accident. No calculations were performed for the components of the system and the construction as a whole. Improper and hasty actions by personnel during the final stage of the experiment also contributed to the cause of the accident.

Figure 2. Mockup of the accident configuration for the May 26, 1971 accident.
