ATOMIC ENERGY OF CANADA LIMITED
CHALK RIVER PROJECT
RESEARCH AND DEVELOPMENT

AN INVESTIGATION OF SOME OF THE CIRCUMSTANCES
PERTINENT TO THE ACCIDENT TO THE NRX REACTOR
OF DECEMBER 12, 1952

NEI-26

MARCH 31, 1953

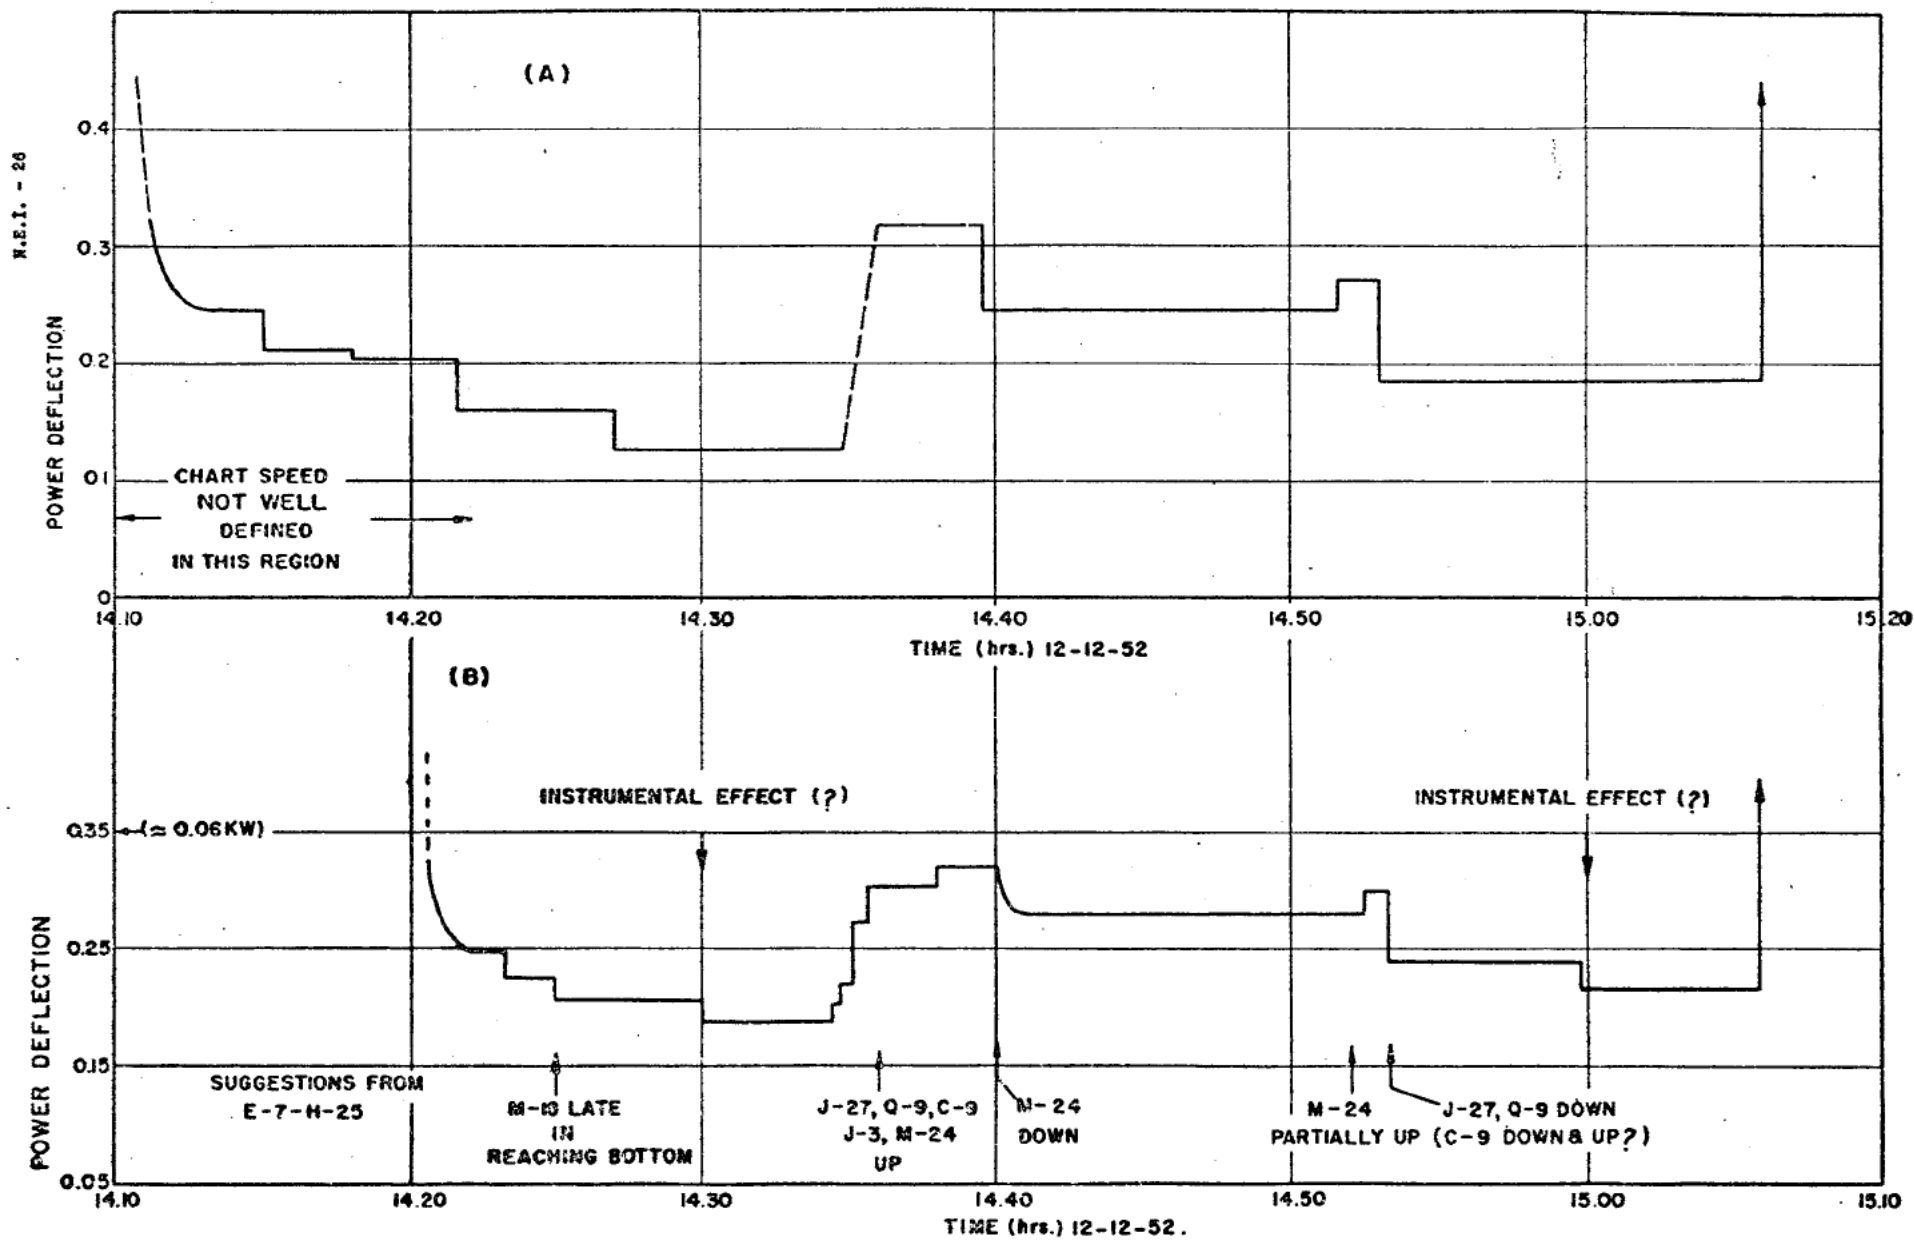
FIG. 1.

The section of these records covering the interval following the shut-down from the preceding critical height measurements up to the accident is reproduced in figure 1. These reproductions represent analyses of the records using a travelling microscope. Since the pen deflections of the recorders only amounted to a few millimetres, they should be regarded with some reserve, particularly since the zero corrections are uncertain. However, essentially all the changes in the power level can be accounted for, from the information given by E-7-H-25, by shut-off rods rising and falling. It is to be pointed out that the magnitude of the changes are not necessarily the same for each record. This can be attributed to distortions in the flux distribution by the rods.

There is no reason to believe that the low point of these records at 14.30 hours did not represent a condition of the reactor similar to that at 05.57 hours and almost certainly (see Appendix) one in which all the shut-off rods and the control rod were down. Consequently, it is evident that all the rods were not down immediately before 15.07 hours.

it can be deduced from the north and south thermal power levels at 15.00 hours that the reactor was approximately 5 to 8 and 10 to 12 mk respectively closer to critical than it was at 14.30 hours. The discrepancies can be readily accounted for by uncertainties in the zero errors of the records and by flux distortions in the reactor.

ENLARGEMENT OF (A) SOUTH & (B) NORTH THERMAL COLUMN ION CHAMBER RECORDINGS.

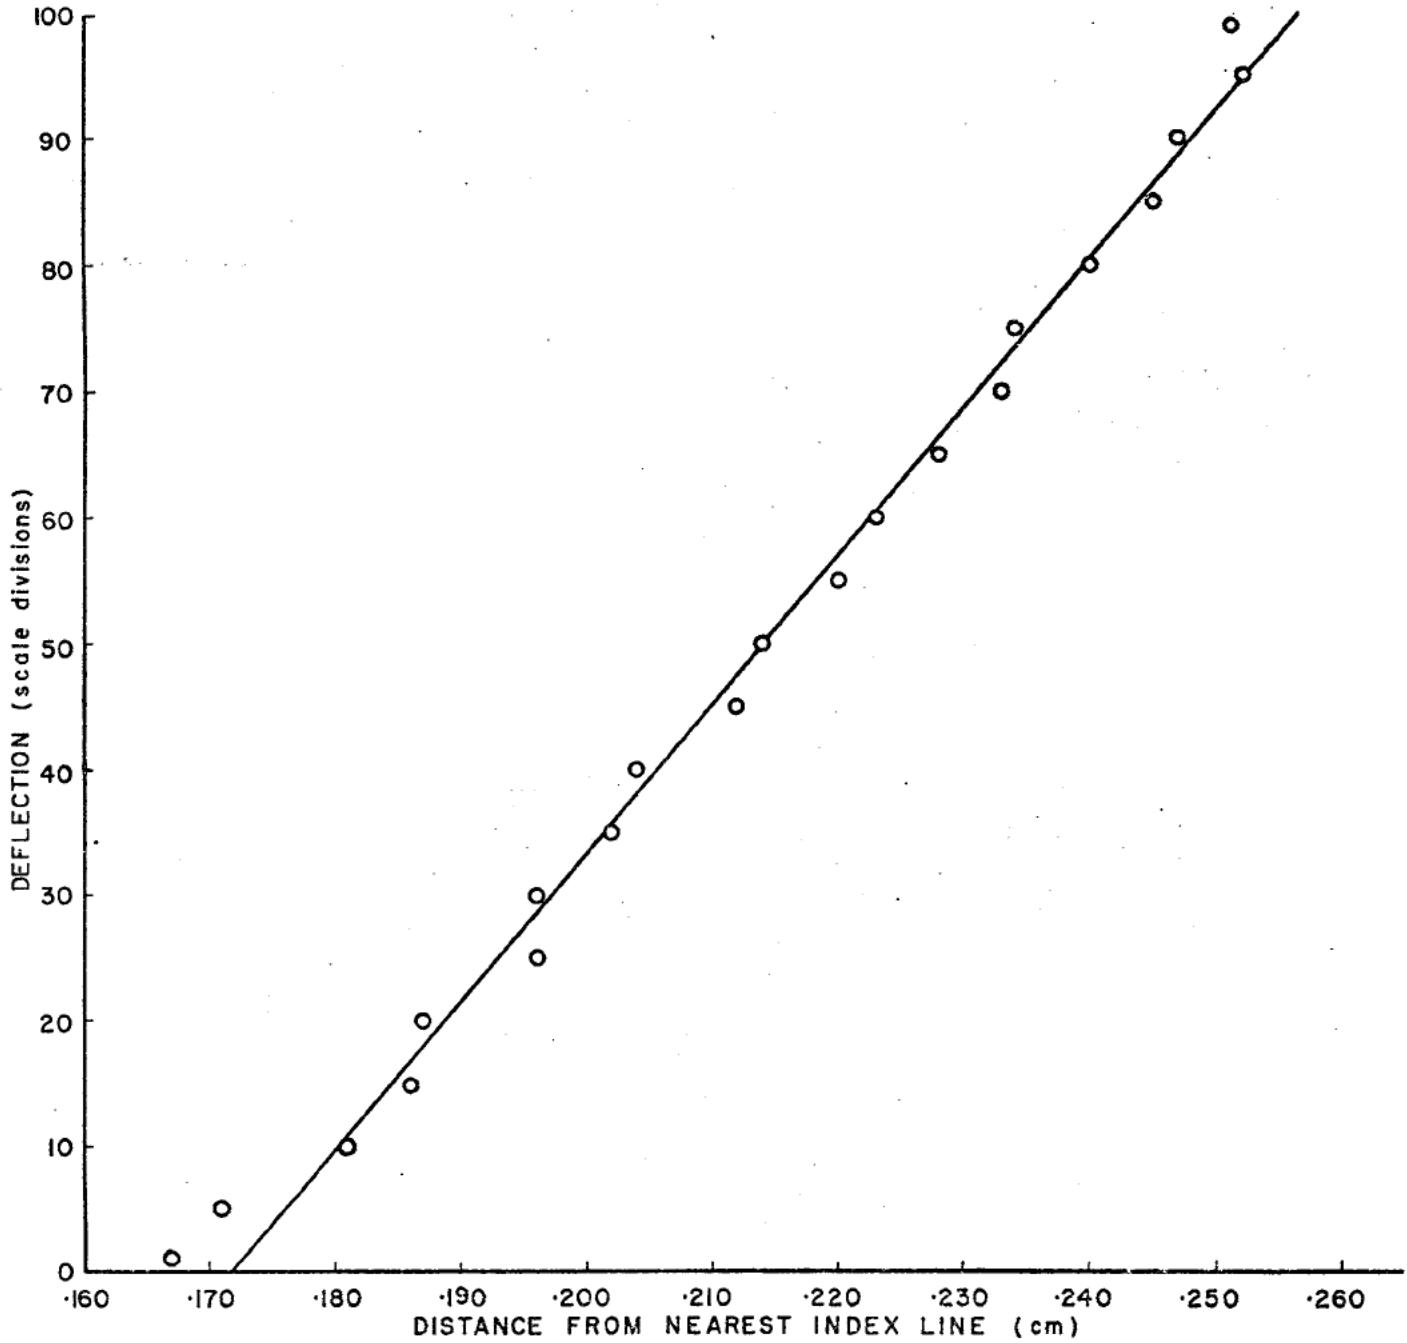
FIG. 2 NORTH THERMAL COLUMN, ANALYSIS OF RECORD

The north thermal column recorder was taken for further investigation. The analysis described above is presented in figure 2. The actual D.C. amplifier and recorder used were removed from the control room and set up alongside the electronic pile analogue. The output power indication from the analogue is in the form of a voltage up to a maximum of 200 volts. This was converted to an effective infinite impedance constant current source simulating an ion chamber by feeding the voltage to the D.C. amplifier input through a $2 \times 10^8 \Omega$ resistor. The impedance conditions were satisfied on the range used during the power transient since the input impedance was $5 \times 10^8 \Omega / \text{gain of feedback} = 5 \times 10^5 \Omega$. The input was loaded with 3000 pf, the estimated capacity load in the pile installation. In this way it was hoped that all time constant effects were reproduced.

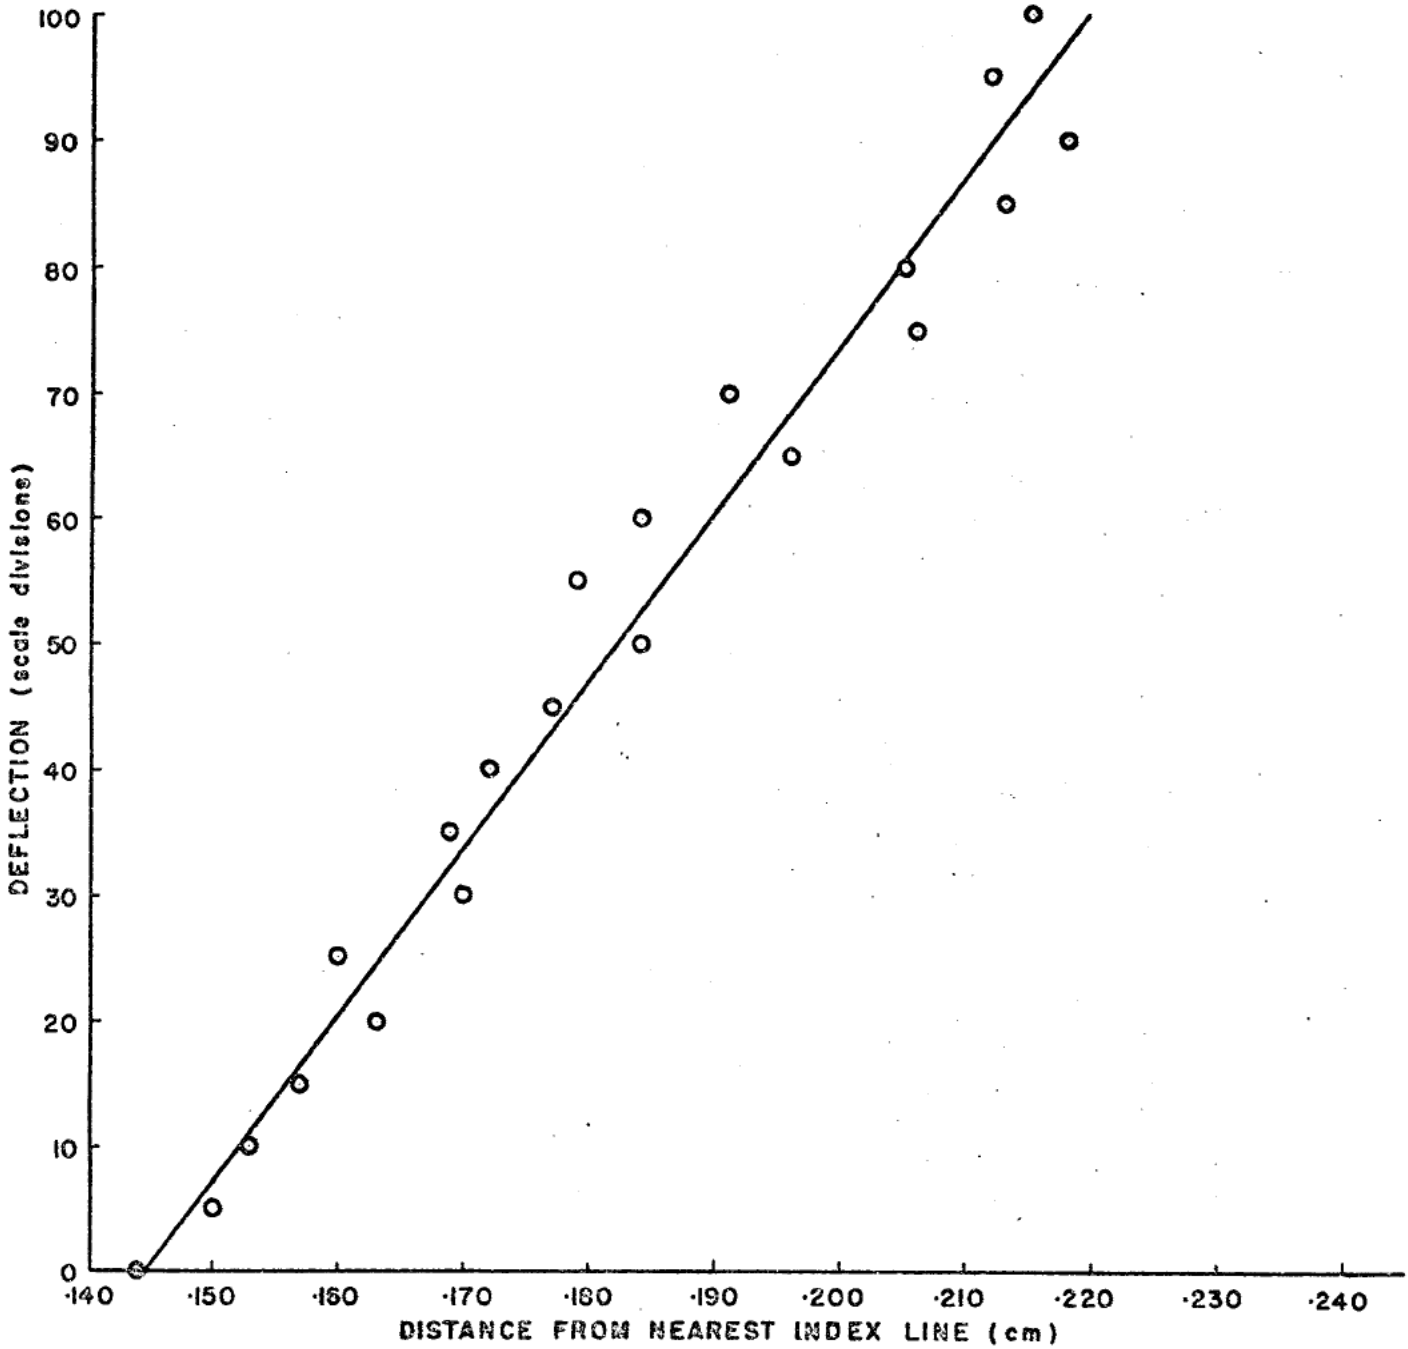
FIG. 3 BROWN RECORDER AND DC AMPLIFIER. EFFECT OF OVERLOAD SIGNAL

In the first instance a number of power transients were simulated by suddenly unbalancing the D.C. amplifier, thus presenting the recorder with a gross overload signal. The transit time of the pen was found to be 20.4 seconds consistently. The traces obtained were analysed by the method described and plotted in the same manner as figure 1. Each analysis gave essentially a straight line but the transit time deduced varied from 22.8 to 37.2 seconds as compared with the directly measured time of 20.4 seconds. A typical analysis giving a transit time of 26.5 seconds is shown in figure 3. It is believed that this spread of deduced times originated from lack of perpendicularity and variation of the angle between the time and deflection axes of the recorder within the scale of measurements. This is not surprising.

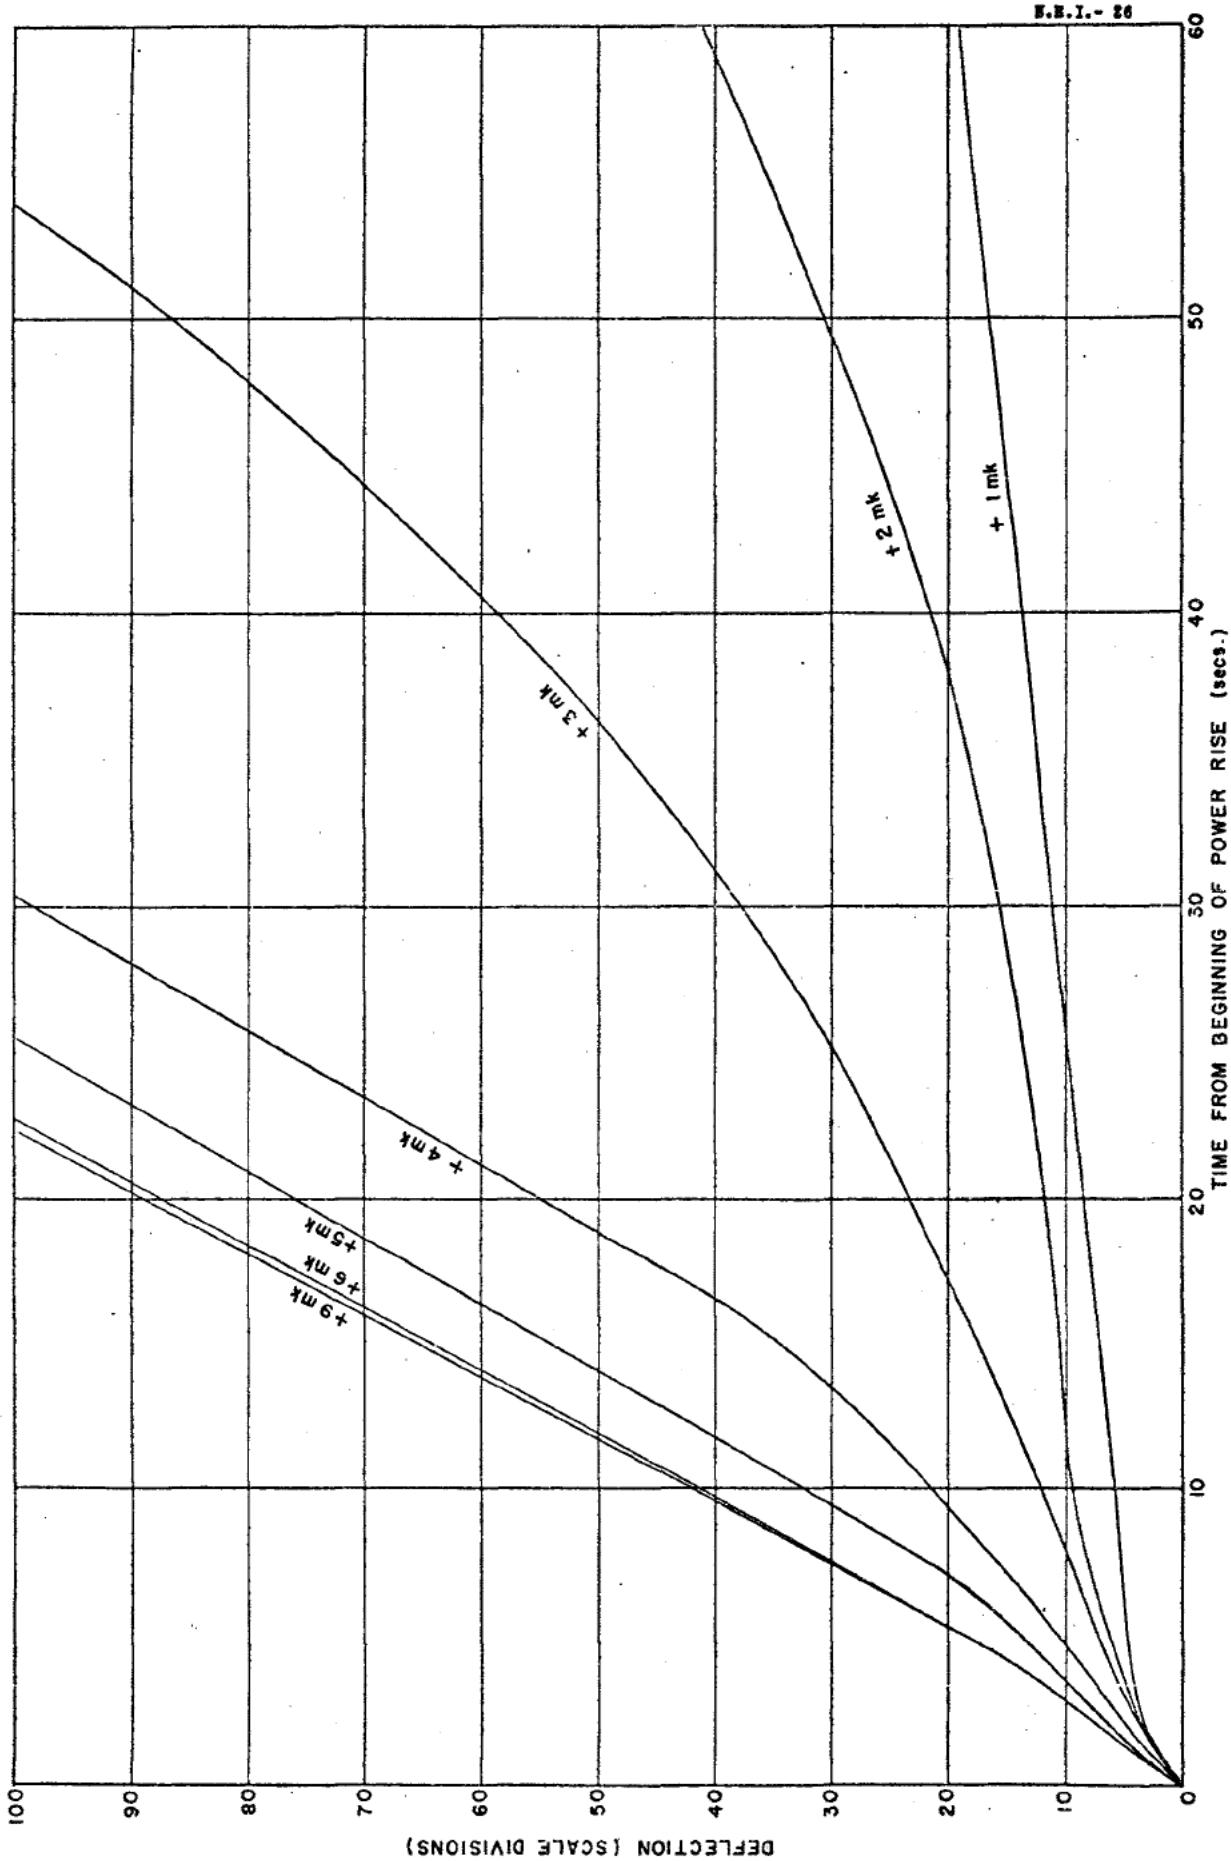
FIG. 4.

BROWN RECORDER AND D.C. AMPLIFIER FROM N.T.C. CONNECTED TO PILE ANALOGUE
CHART SPEED 247/hr. EFFECT OF REMOVING 29.5 mk. IN ~ 2 secs.

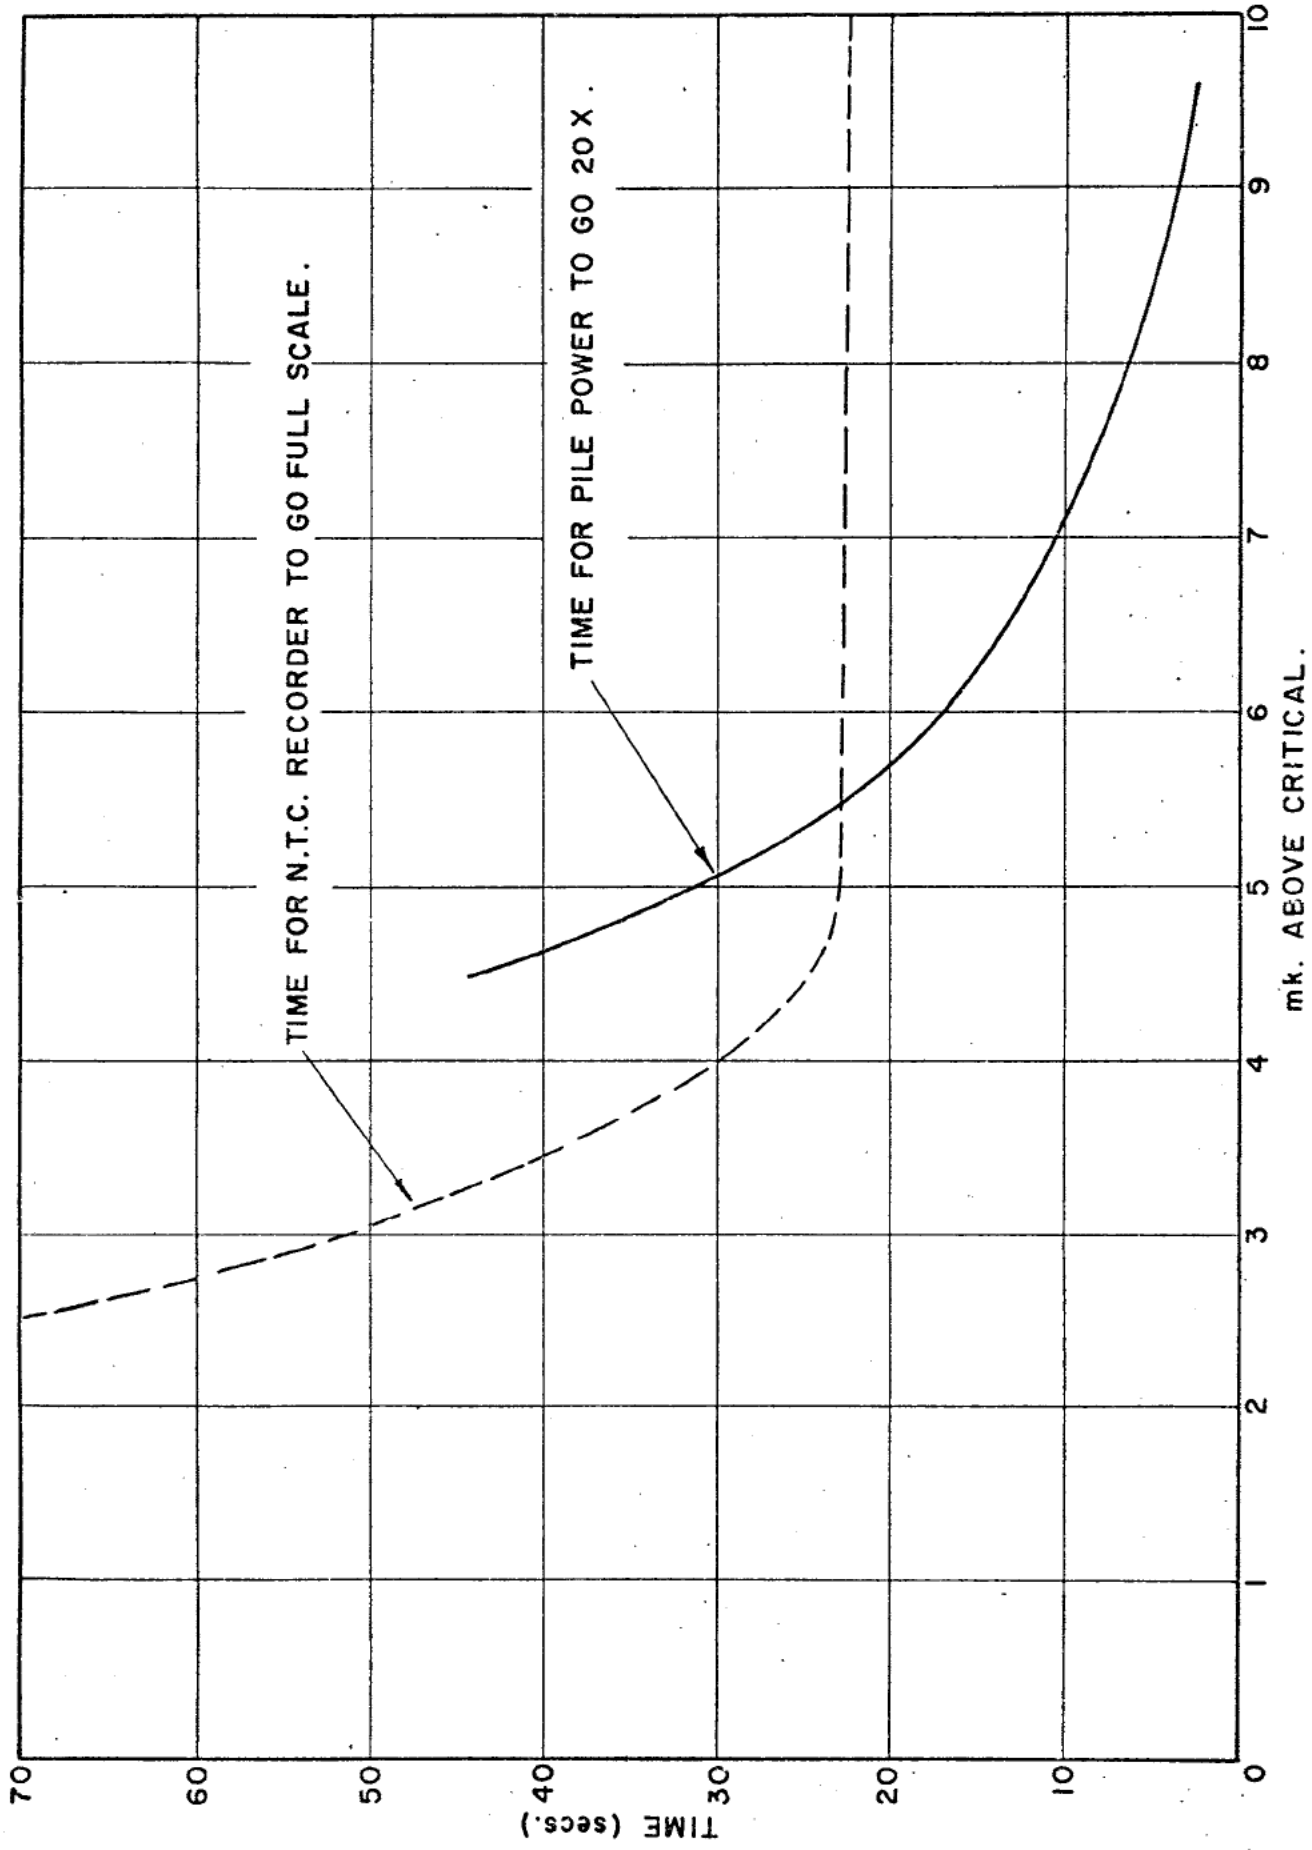
FIG. 5.

RATES OF RISE FROM PILE ANALOGUE EXTRACTING 29.5 mk. IN ~ 2 secs.

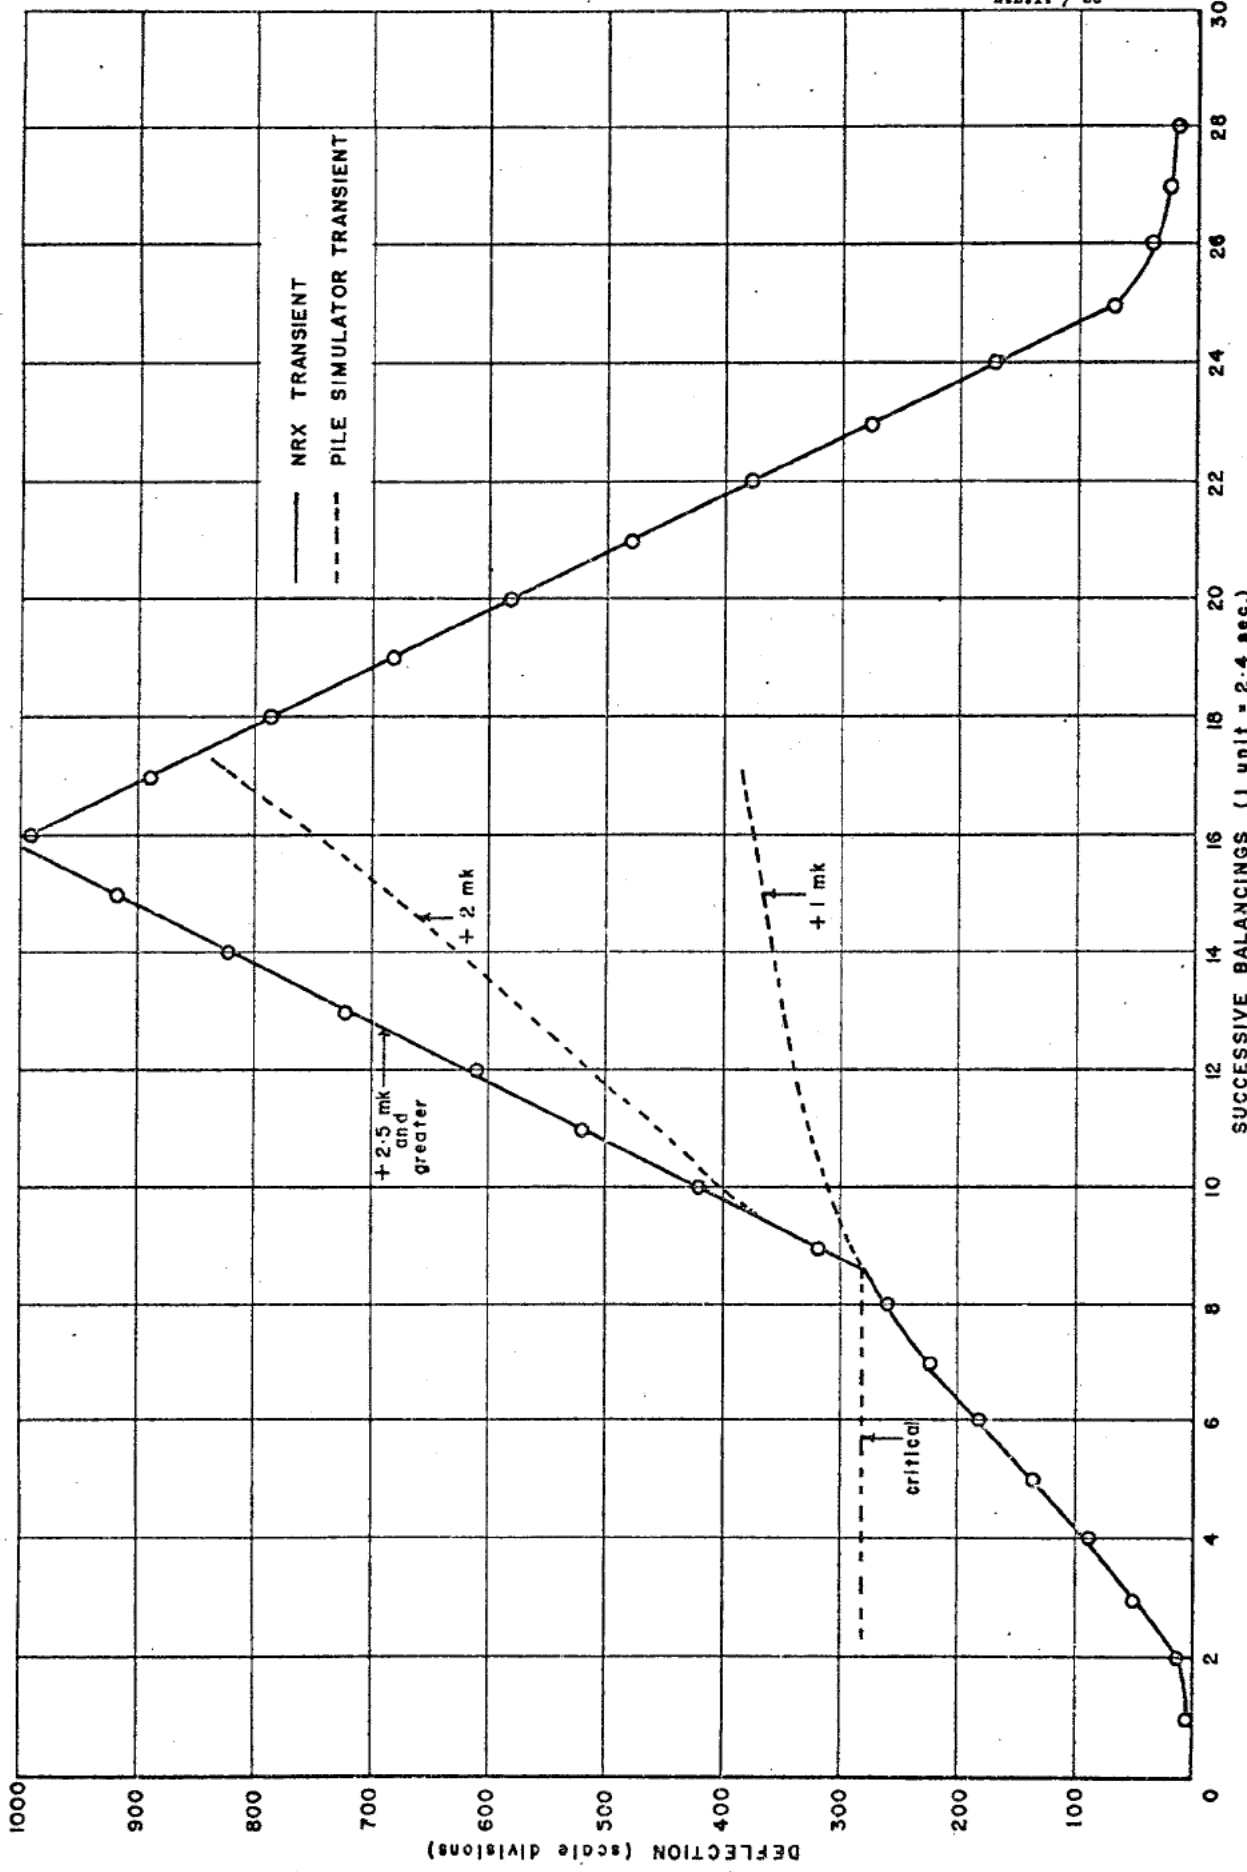
FIG. 6 E-7-L-109A ANALYSIS OF RECORD. POSITIONS OF RECORDER PEN ON SUCCESSIVE BALANCINGS

The record of the power transient consisted of a barely inked broken line and an attempt to analyse it by the method given above proved unsatisfactory indicating an excessive tilt of the instrument axes compared with the width of the transient. However, examination of the trace showed that the stationary positions of the pen during successive attempts made by the instrument servo-mechanism, to achieve balance, could be readily distinguished. Since the time intervals between successive balance attempts is well defined a very good plot could be made of instrument reading against time. This is shown in figure 6.

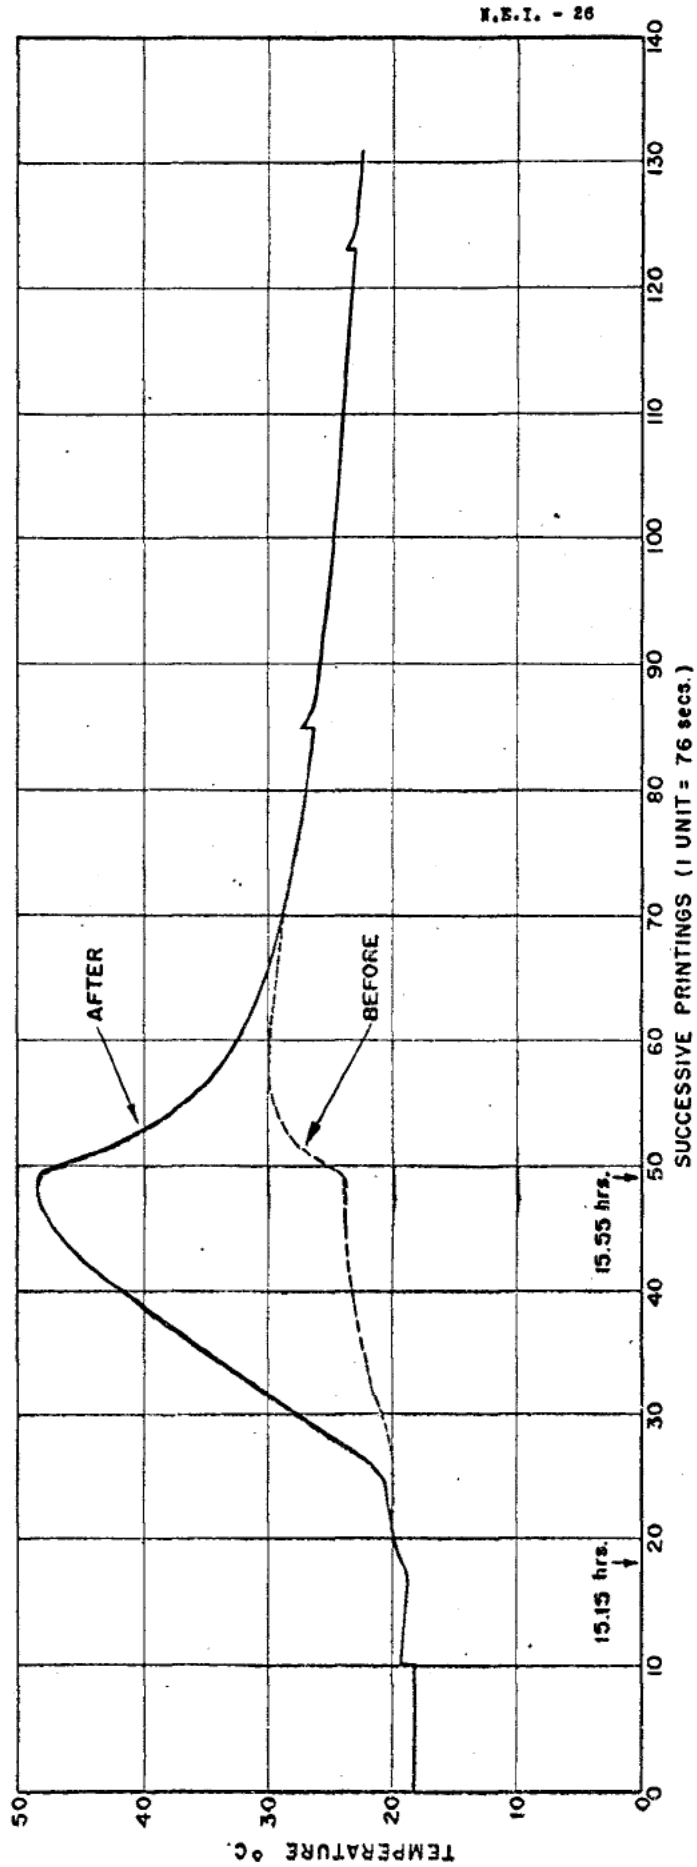
FIG. 8.

the accident is shown in figure 8. The times noted are taken from the chart. The sharp pips occurring about once per hour are associated with the standardizing procedure of the recorder.

TEMPERATURES BEFORE AND AFTER THE CATALYST.

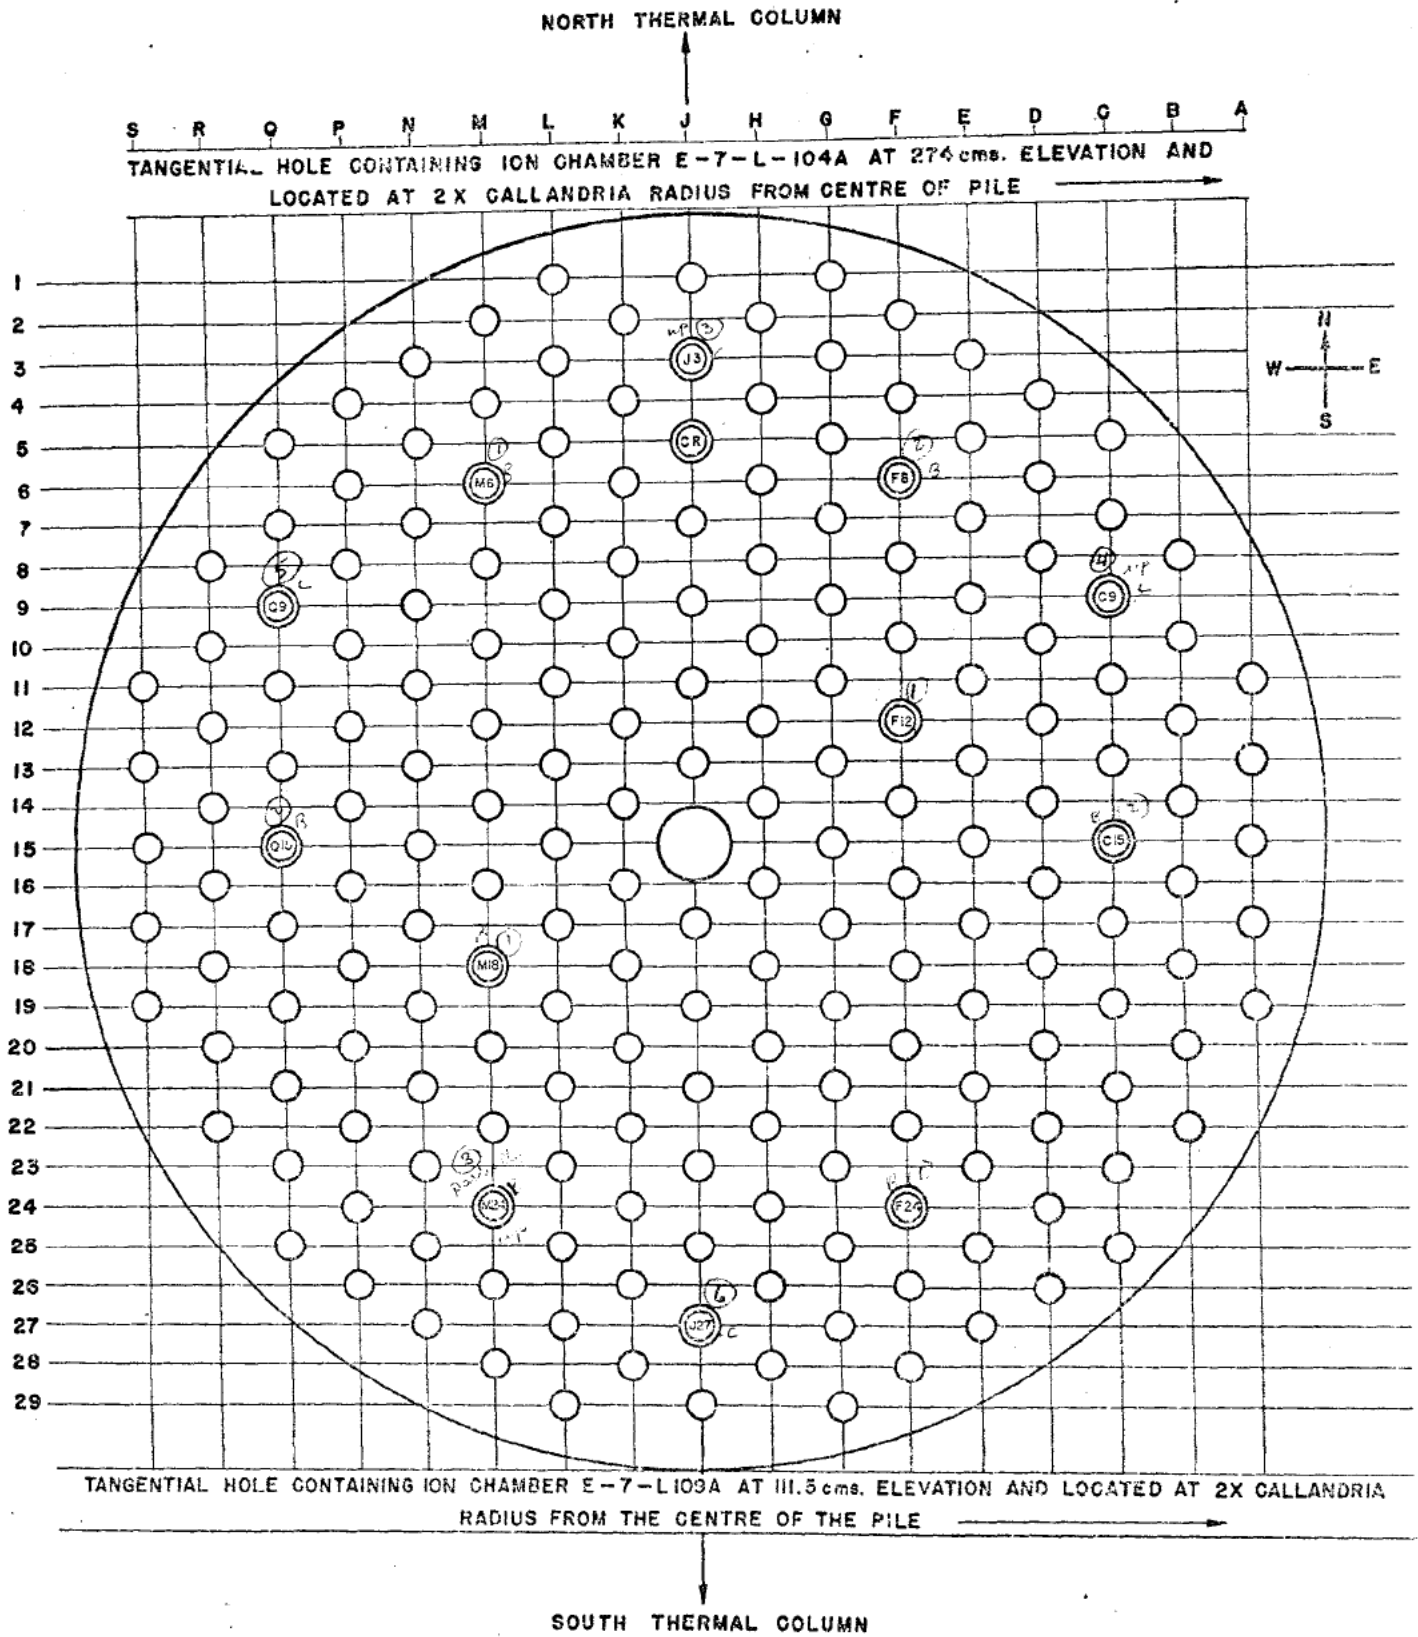
FIG. 9.

Figure 9 is appended to show the geometry of the reactor and indicate the locations of the various rods and instruments discussed.

SCHEMATIC CROSS SECTION OF THE NRX LATTICE SHOWING THE SHUT-OFF ROD AND CONTROL ROD LOCATIONS AND THE RELATIVE LOCATIONS OF THE VARIOUS INSTRUMENTS DISCUSSED. SHUT-OFF RODS (A) INNER CIRCLE F12, M18. (B) MIDDLE CIRCLE Q15, M6, F6, C15, F24, M24. (C) OUTER CIRCLE Q9, J3, C9, J27.
