NUCLEAR INCIDENT AT THE IDAHO CHEMICAL PROCESSING PLANT

NUCLEAR INCIDENT
at the
IDAHO CHEMICAL PROCESSING PLANT
on
OCTOBER 16, 1959

REPORT OF THE INVESTIGATING COMMITTEE

PHILLIPS PETROLEUM COMPANY - ATOMIC ENERGY DIVISION
U. S. ATOMIC ENERGY COMMISSION - IDAHO OPERATIONS OFFICE
Idaho Falls, Idaho February 15, 1960

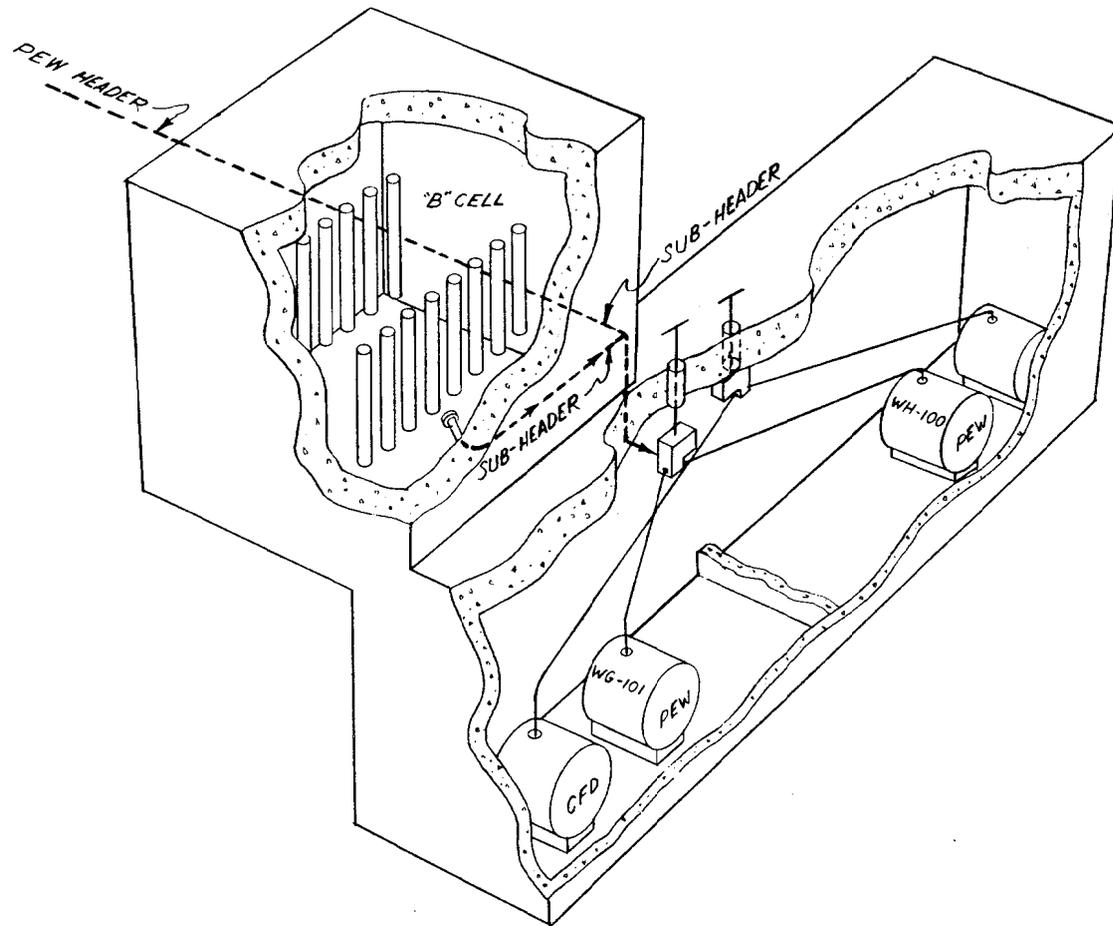
Fig. 4
RELATIVE CELL LOCATION

On the 0800 to 1600 shift of October 14, the diversion spout for the PEW system was switched from the almost full WG-101 tank to the empty WH-100 tank. It was into this latter tank that the uranium solution from the B cell storage banks drained. Figure 4 shows schematically the relative location of storage banks to the waste collection tanks.

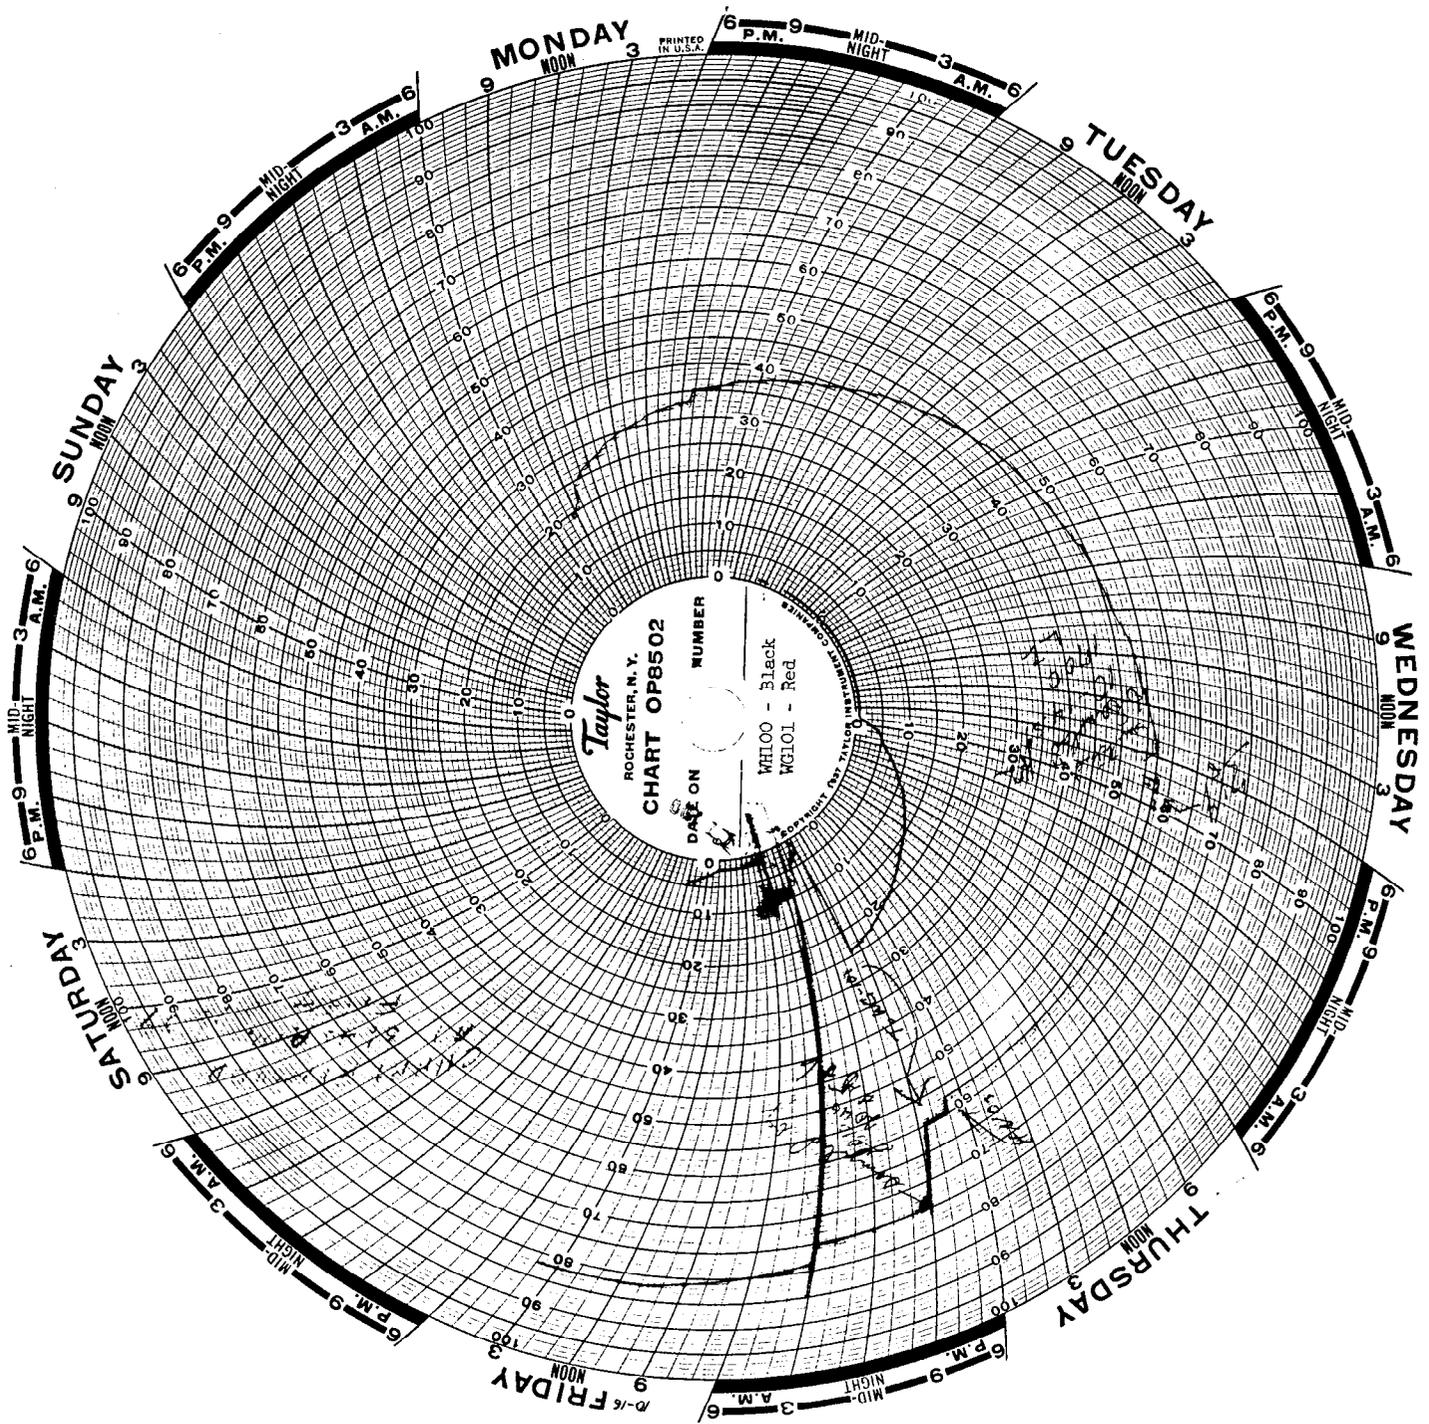
Figure 9
 PEW INSTRUMENT CHART
 0800 October 12 to 1600 October 16

The B cell and waste collection tank charts were recovered for careful examination. Although the PEW diversion spout (Figure 13) was found directed to WG-101 immediately after the incident, the 1600-2400 shift on October 15 had reported that they had switched to WH-100 and the instrument chart (Figure 9) verifies that WH-100 had been filling. At the time of the incident WH-100 volume decreased from about 10 per cent (795 liters) to 3 per cent (76 liters), and WG-101 volume increased from

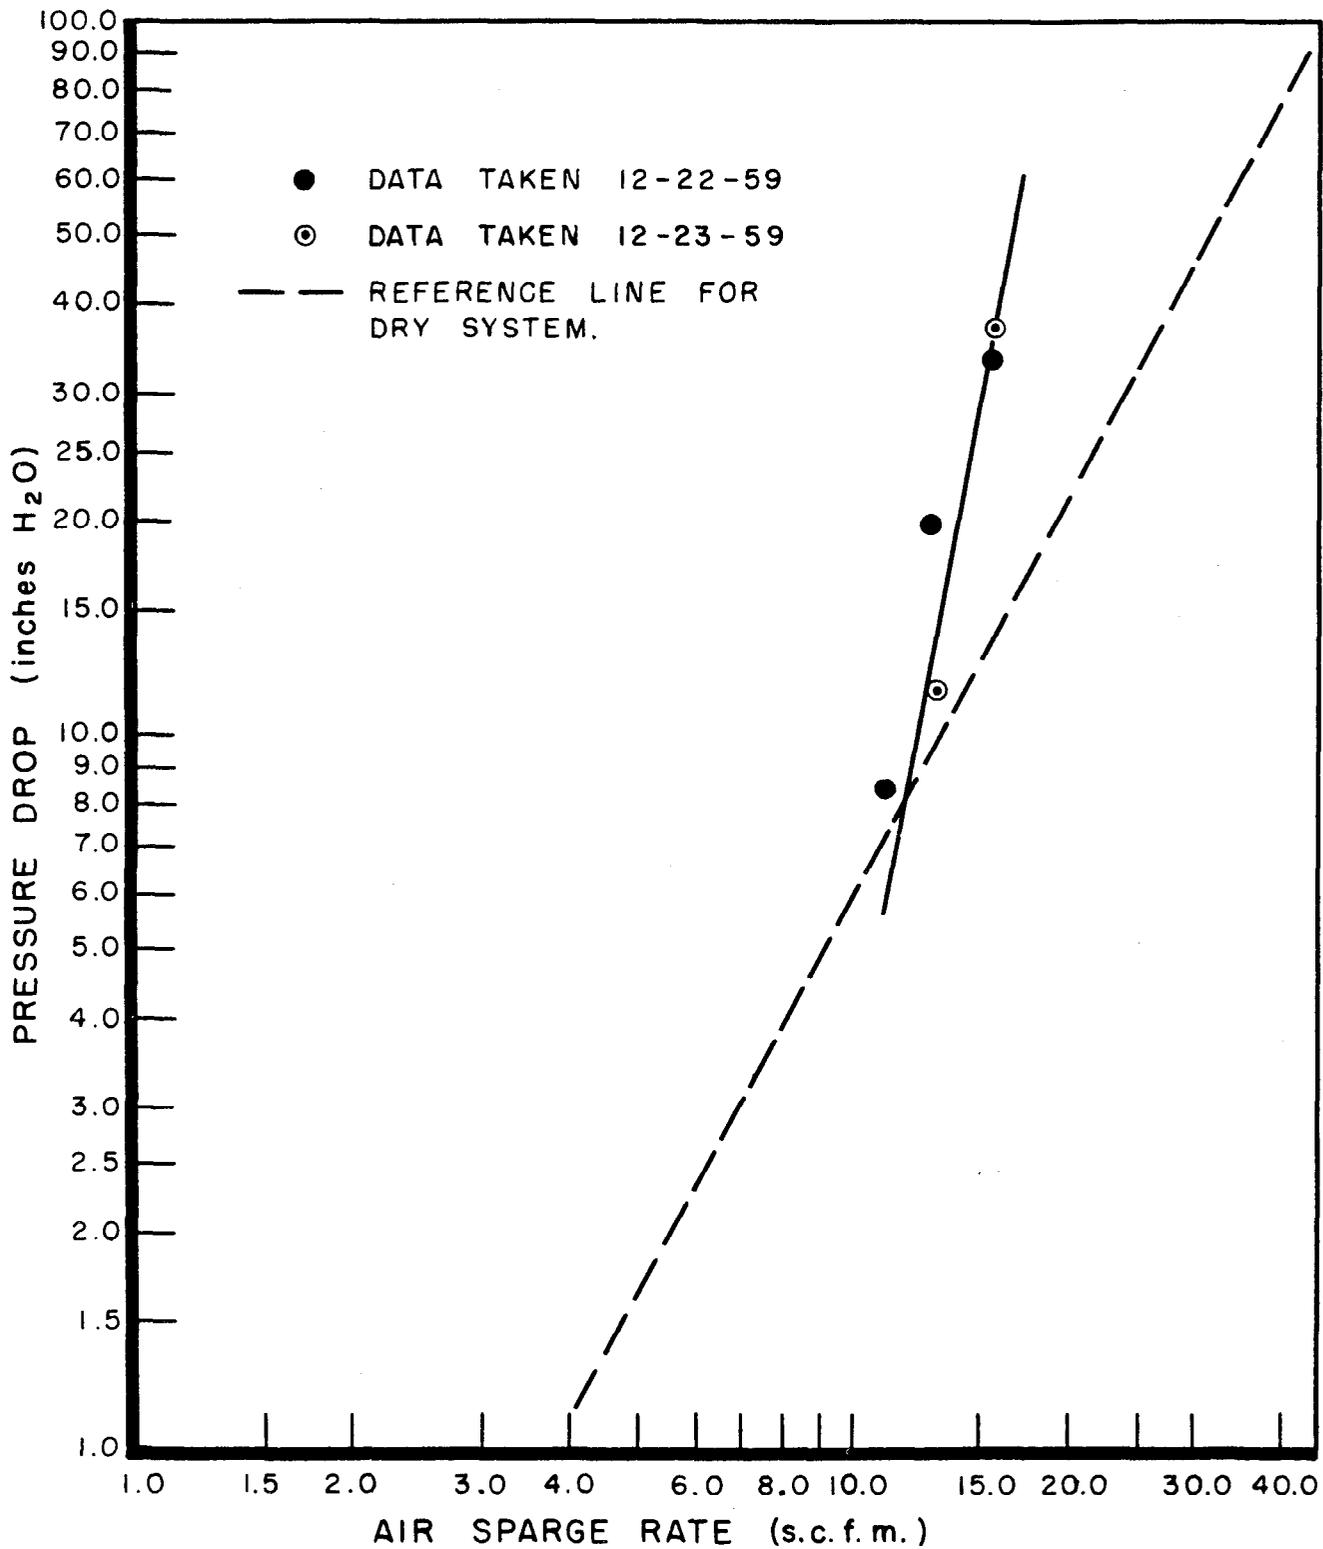
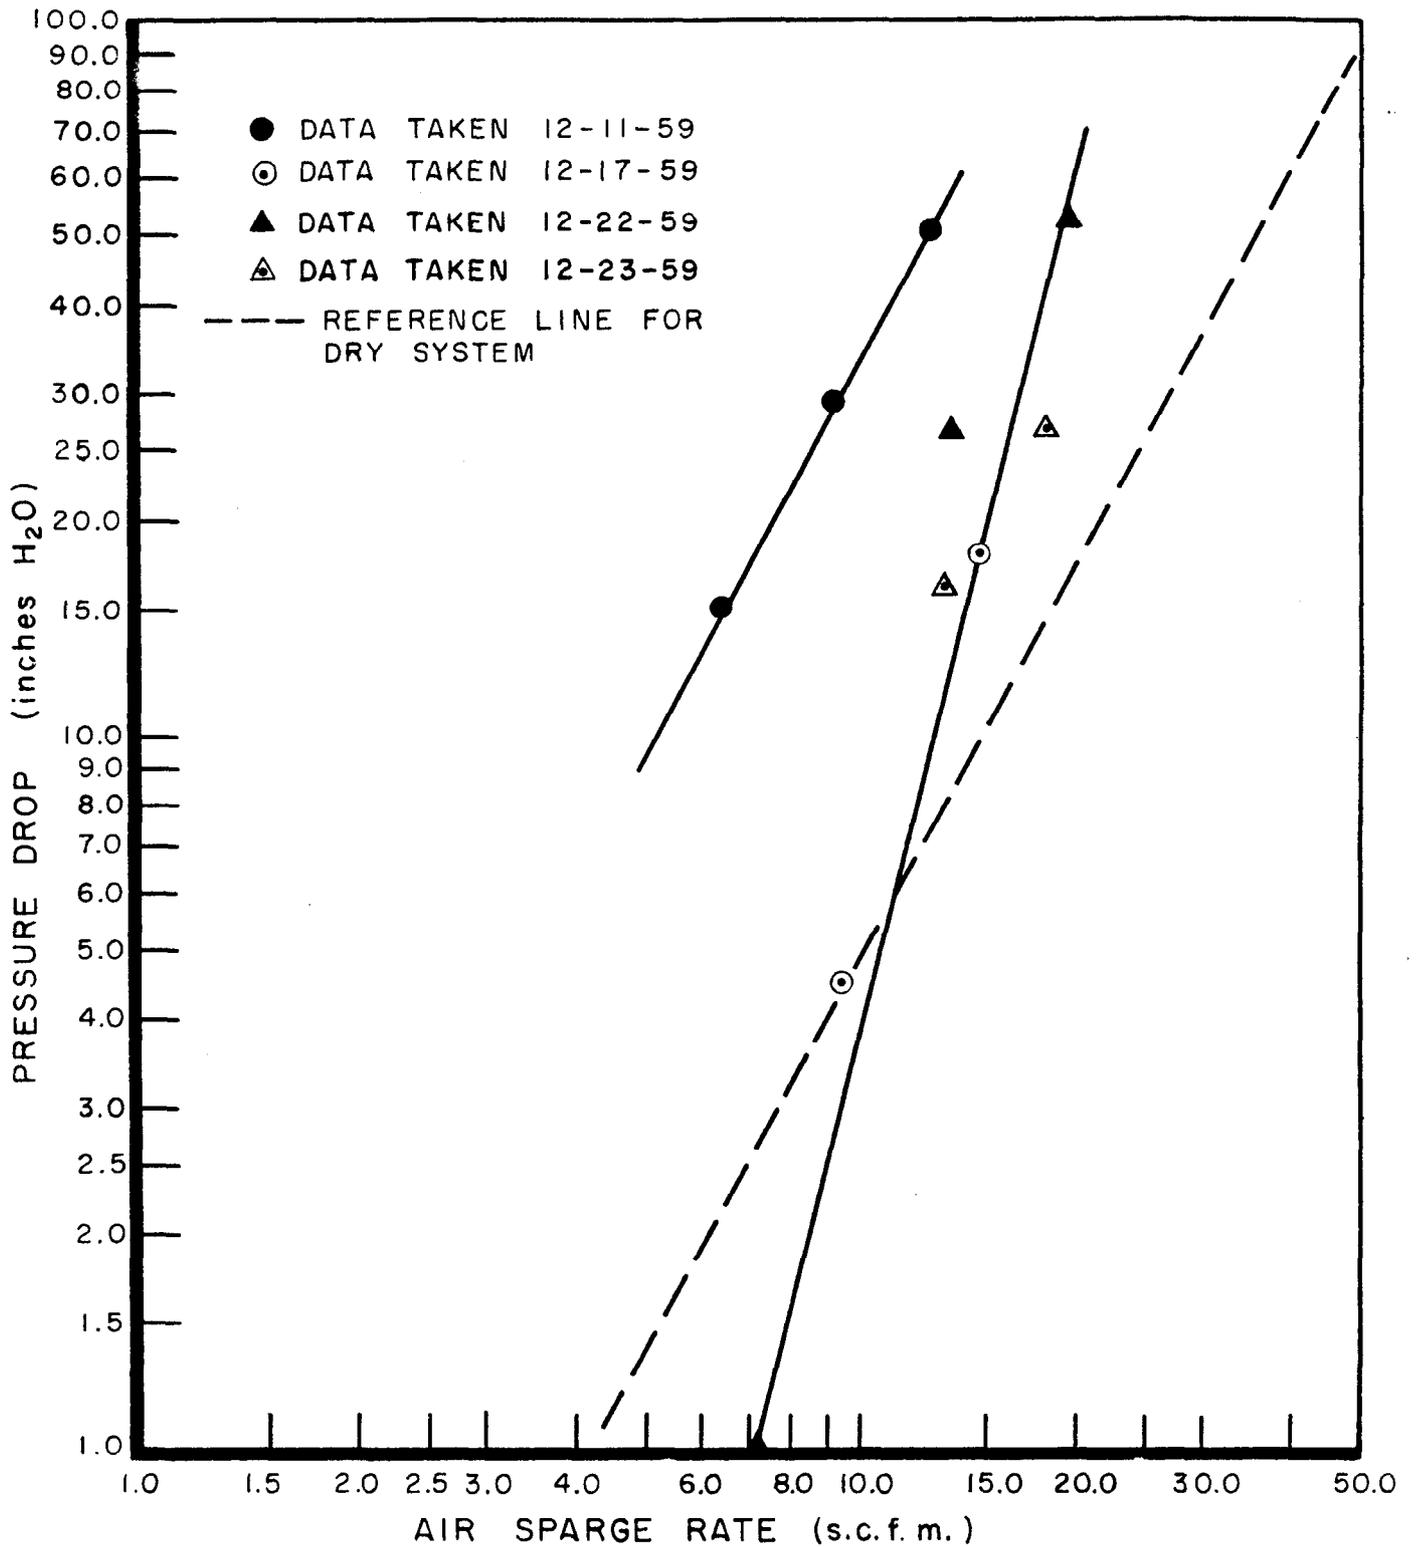
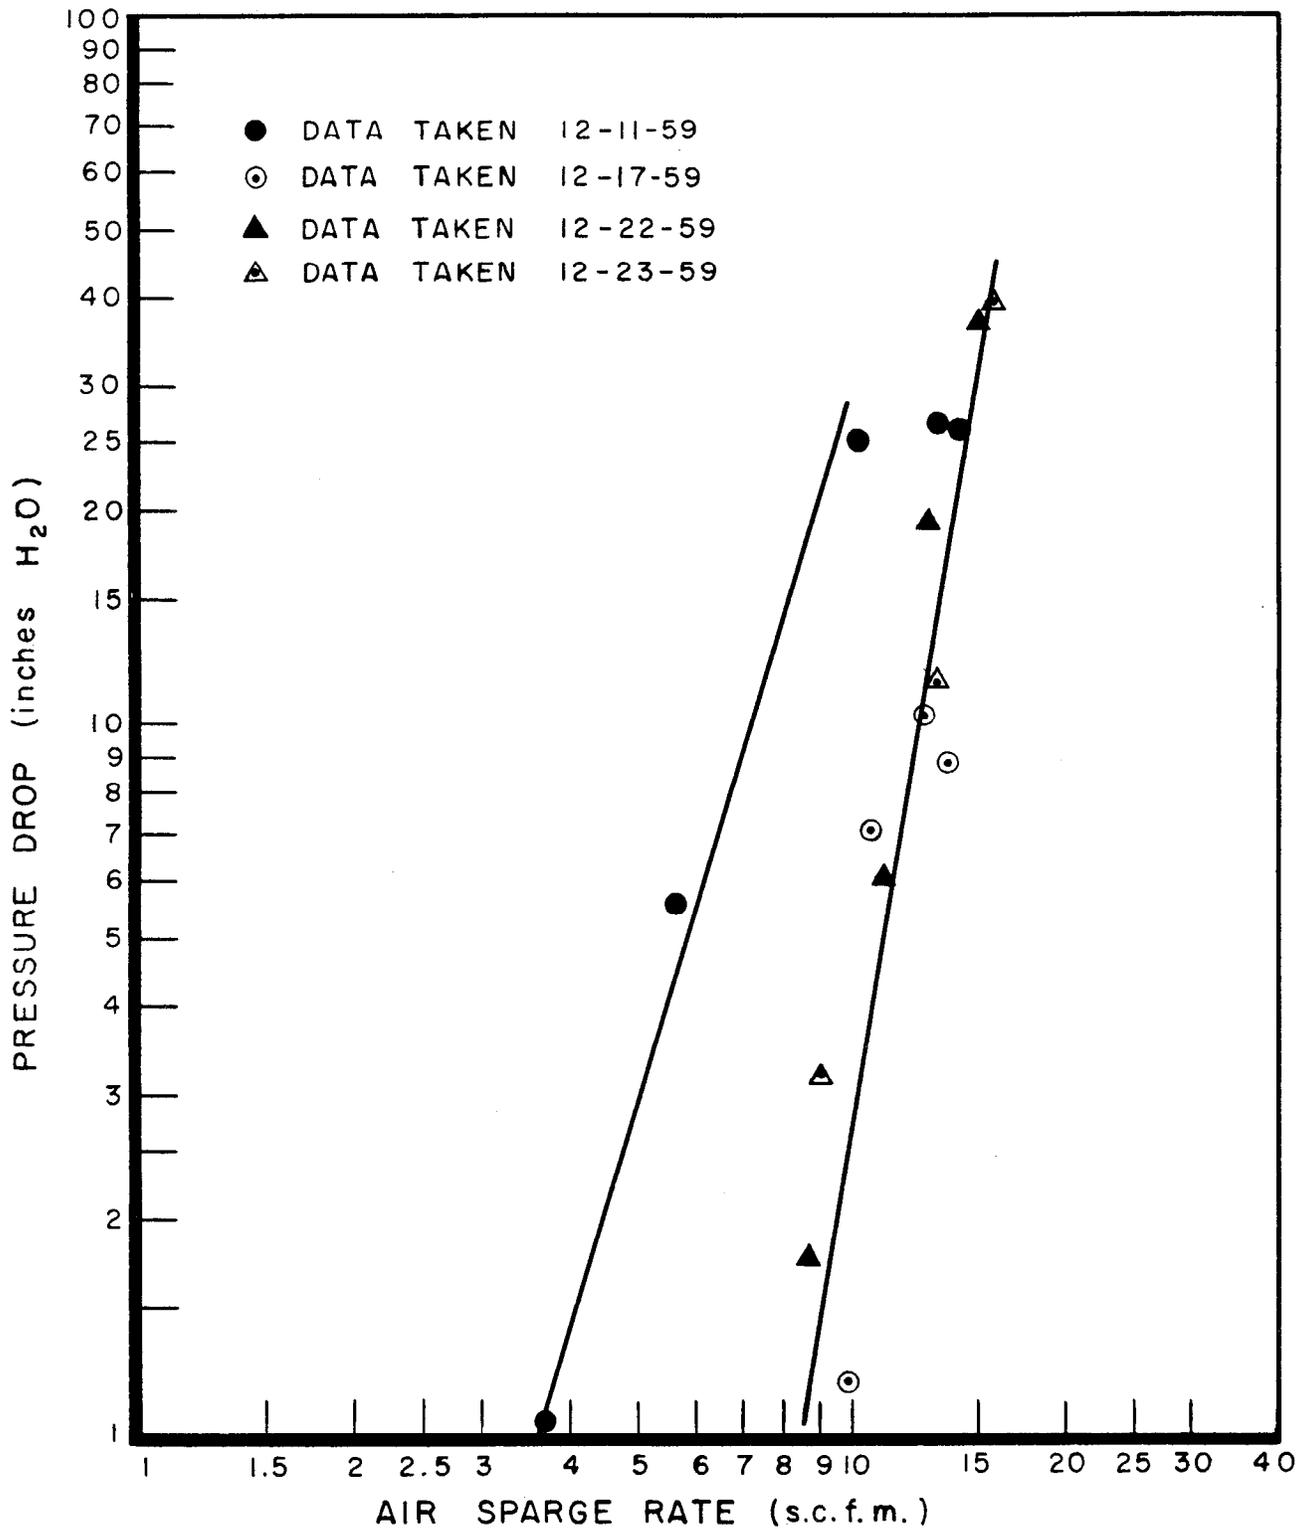
liquid is lifted into the vent lines by the sparge air which in turn creates additional pressure drop. Figures 19, 20, and 21 graph these data and indicate that a sparge rate of approximately 12 SCFM will begin to lift liquid into the vent system. The effect of the liquid in the lines is more pronounced for the vent lines coming off the banks than it is for the common vent line. This is to be expected because there are vertical sections in the bank vent lines while the common line is almost horizontal. Tests also indicate that when sparging is stopped or decreased, the liquid flows out of the vent lines, and normal pressure drops are again obtained with low sparge rates.

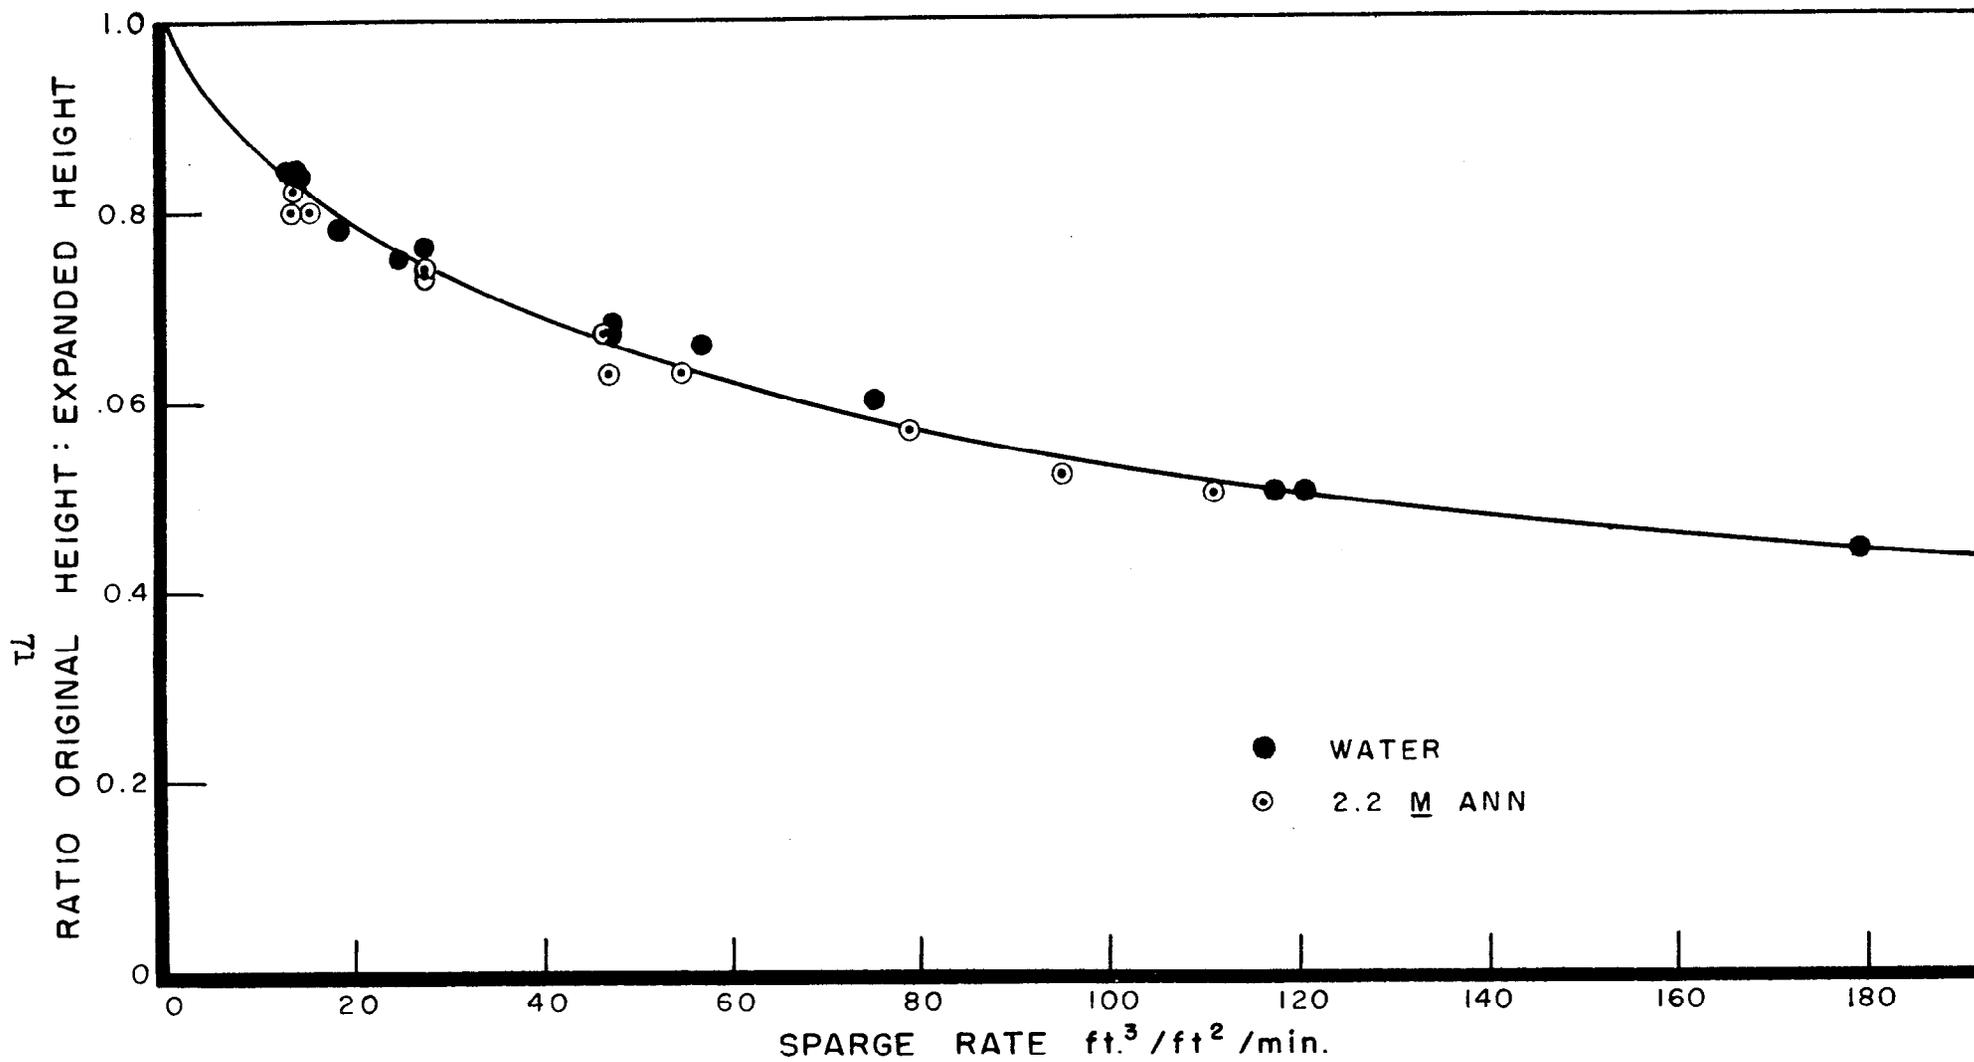
Fig. 22
 EFFECT OF SPARGE RATE ON EXPANSION RATIO
 (4" I. D. x 6' Column)

Sparging tests were made in a 4-inch diameter lucite pipe using both water and 2.2M aluminum nitrate solution to obtain the relationship between sparge rate and the amount of expansion of the air-liquid mixture. The ratio of initial height to expanded height correlates quite well with sparge rate (ft^3 per ft^2 of column cross-sectional area per minute) as shown in Figure 22. With the vessels in B cell filled to incident depth of 98 inches, the expansion ratio to put liquid into the vent system would be approximately 1.22. From Figure 22 it is seen that a sparge rate of 14 cubic feet per square foot of column cross-sectional area per minute or 15 SCFM per bank should be required. The plant scale tests, however, have shown that a sparge rate of approximately 12 SCFM is required to lift liquid into the vent system from either bank (see Figures 19, 20, and 21). A scaleup factor may account for the difference, or it is possible that one or more of the vessels in one bank may receive more sparge air than the others. In either case these data are considered to be in close agreement. As would be expected, liquid is also transferred to the sump from the B-100 bank by a sparge rate of approximately 12 SCFM.
