U.S. Department of Energy

Trip Report

Visit to Tokyo and Tokai-Mura, Japan

**Information Exchange with
Government of Japan Concerning
The September 30, 1999
Tokai-Mura
Criticality Accident**

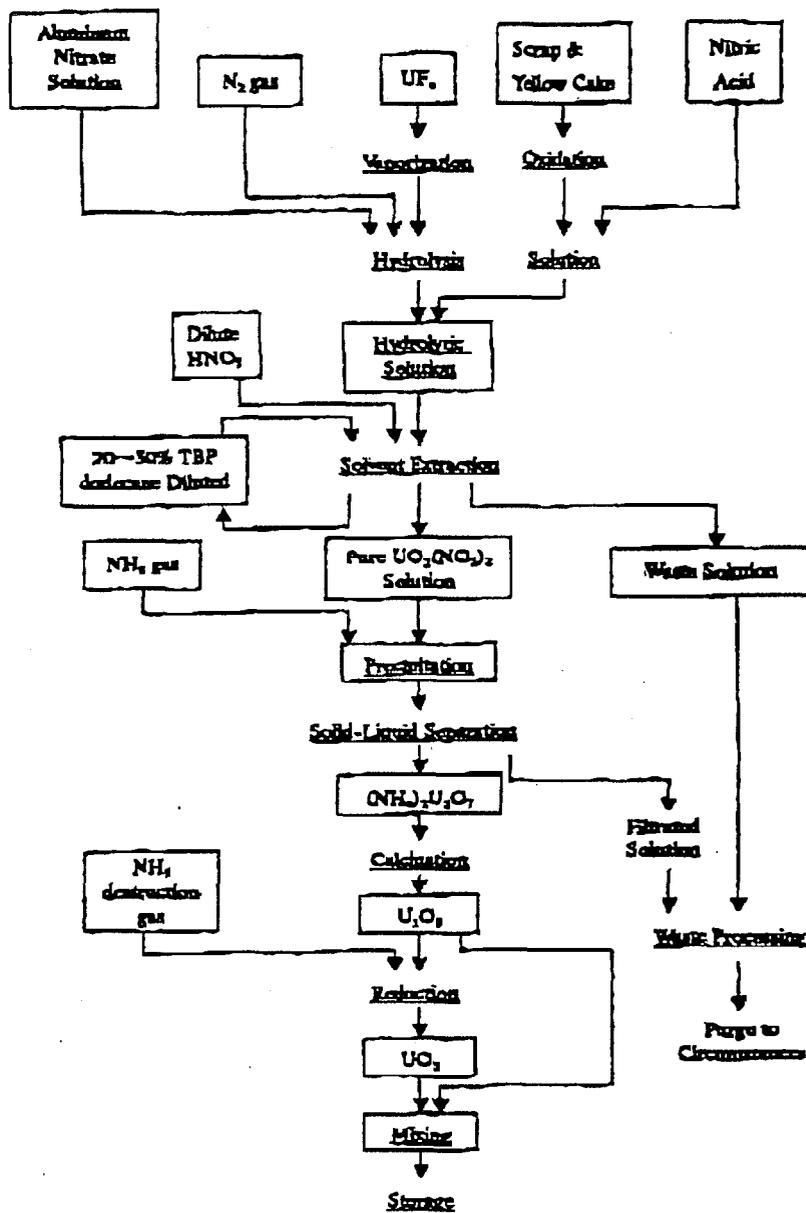
Figure 1. A schematic diagram of the JCO conversion process

The entire process described above and shown in Figures 1 and 2 of Attachment D was the process approved by the Science and Technology Agency.
