ATOMIC ENERGY OF CANADA LIMITED
CHALK RIVER PROJECT
RESEARCH AND DEVELOPMENT

AN INVESTIGATION OF SOME OF THE CIRCUMSTANCES
PERTINENT TO THE ACCIDENT TO THE NRX REACTOR
OF DECEMBER 12, 1952

NEI-26

MARCH 31, 1953

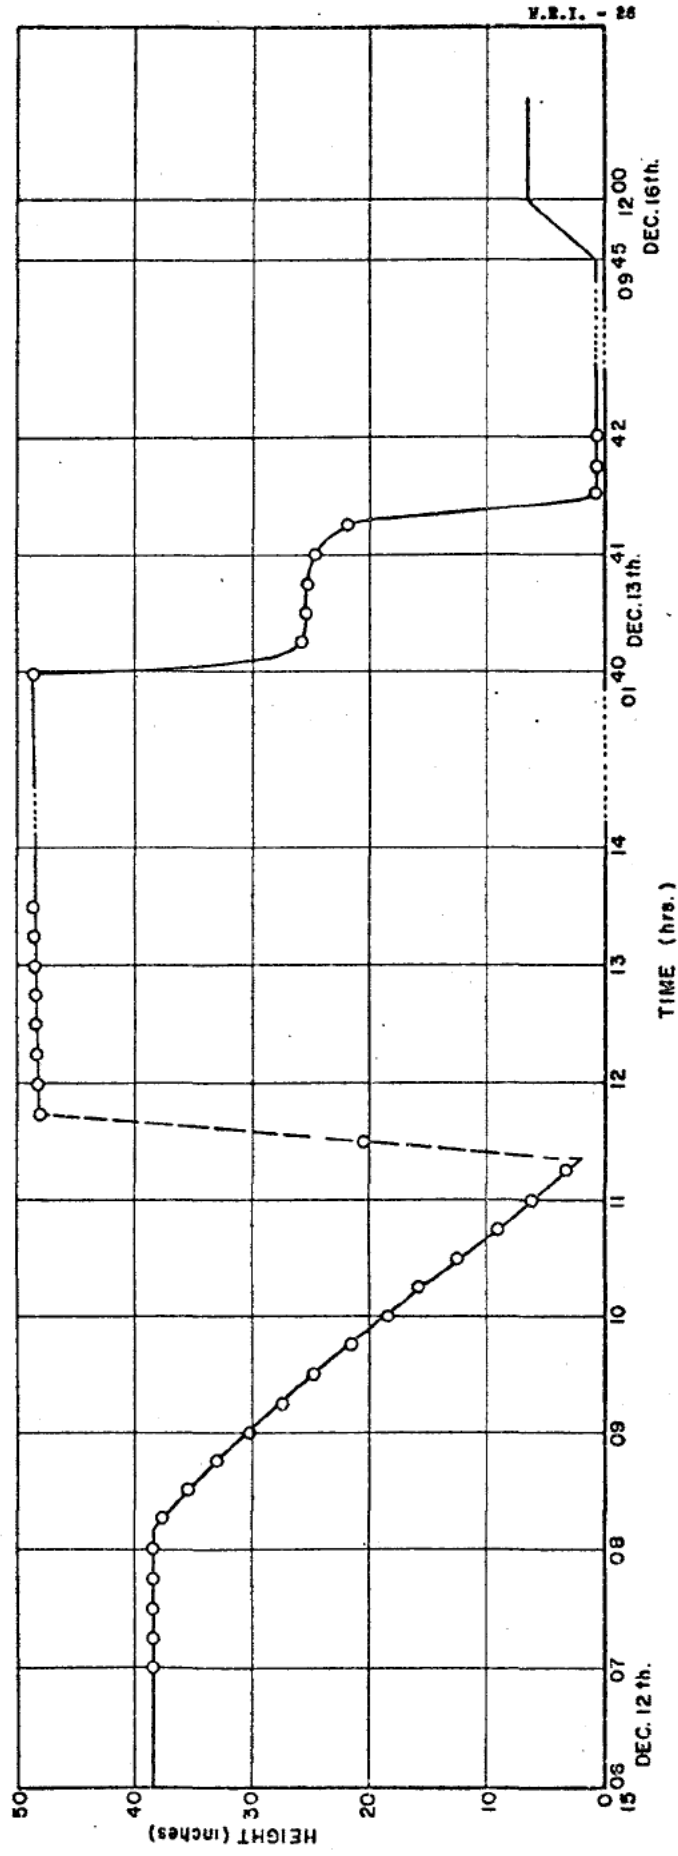
FIG. 7

The height of the gasholder is recorded by a Leeds and Northrup "Micromax" recorder, which prints the position every fifteen seconds. The position indication is obtained from a potentiometer driven by a wire attached to the top of the gasholder. The indicating system appeared to be in good working order when inspected after the accident. A summary of the record during and after the accident is shown in figure 7. The time scale is taken directly from the chart.
