#### **Procurement Process Challenges, Issues, and Lessons Learned from IER 305 and IER 441**

NCSP Technical Program Review February 21, 2024 Hosted by Brookhaven National Laboratory

SAND2024-01649PE

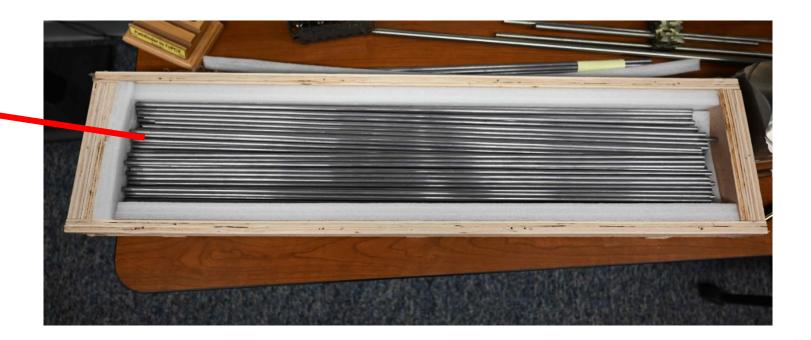
## Tantalum Rod Marking (Eagle Mfg.) Delivered On Time

- Had to re-mark serial number per drawing requirements
  - Laser marking was done by SNL TA-5 machine shop
- The issue with the original marking process (stencil): not permanent rubbing off some of the rods after minimal handling

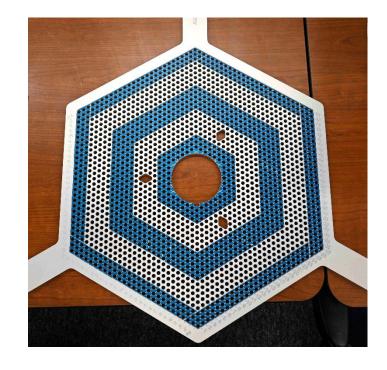
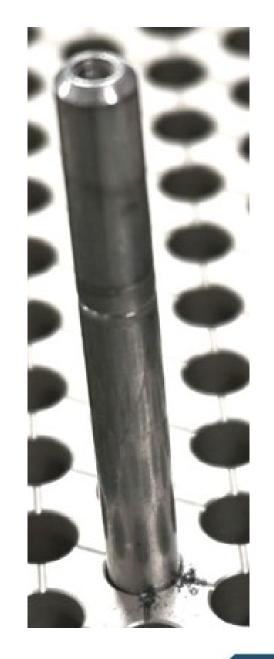
#### **Guide Plate Non Conformance (Ridgeline Mfg.)**

- Anodize color not consistent with other grid plates
  - This issue alone could have been overlooked

- Chamfer on CE/SE cutouts on both sides did not meet drawing requirements
  - Control and Safety Elements do not drop correctly and may get held up
- "Addressing Lines" had errors and did not meet drawing requirements
- Grid plate holes not chamfered and deburred properly even after reworked
  - Outside of fuel rods being shaved off when loaded/unloaded

- Non conformances (not anodized, holes not chamfered, etc.)
    - Sent back to Ridgeline for corrections
    - Reworked guide plate still did not meet requirements

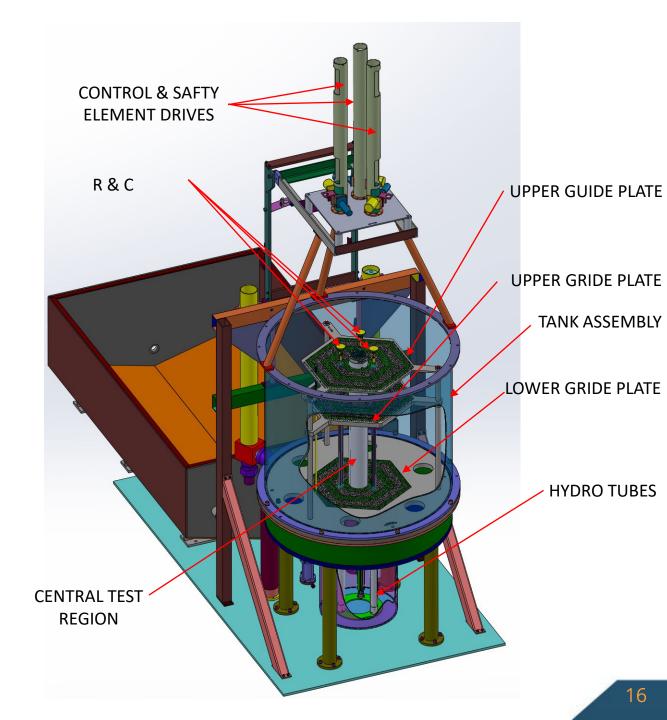
## IER 441 OVERVIEW

- Control and Safety Element bundle plates
  - Maintain spacing of the 4 rod clusters
- Grid Plates (Guide, Upper, and Lower)
  - Maintain spacing of fuel rods
  - Triangular pitch (1.02 cm)
- Central test region
  - Outer Diameter 9.5 cm
  - Length 78 cm
  - Dry cavity

- Lined with cadmium
- Maintain spacing of test rods
- 85 test rod locations
- Triangular pitch (0.81 cm)
- ° Tantalum rods
  - Pure tantalum (> 99.95%)
  - Dimensions match fuel rods (about 1 cm longer)
- Hydro Tubes and Springs
  - Gravity drop of control and safety elements
